Part VII
Case studies:
industrial uses

36

AUTOMOBILE SEAT BELTS

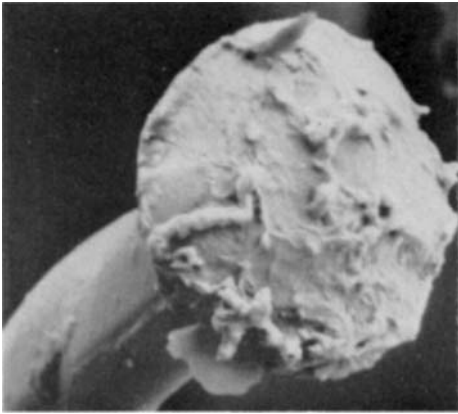
1

The appearance of a nylon filament found in webbing failed in simple tension, 37A(1), is typical of the fibres found in this and similar specimens, and is a mushroom end, such as is found in single-fibre tests at high strain rates. This form results from rapid load transfer after break starts. Polyester fibres have a similar form in webbing failed in simple tension.

(1) Nylon filament from webbing broken in tensile test. (2) Nylon filament from webbing broken in drop test. (3) Polyester filament from webbing broken in drop test. (4) Polyester filament from webbing failed in drop test with D-ring. (5) Nylon filament from webbing broken in drop test over sheet metal edge.

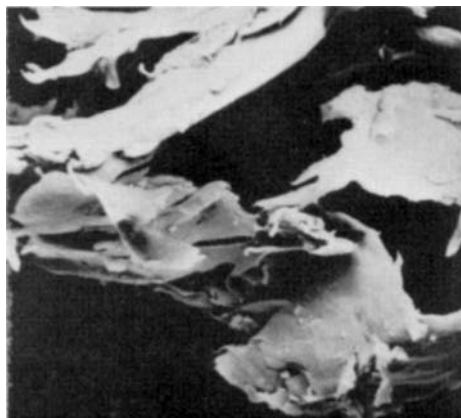
1 |—| 20 μm

In service, seat-belt webbing is subjected to many forms of abuse. Perhaps the two most common are being dragged along outside a vehicle and being repeatedly trapped between the door and the door frame of a vehicle. To simulate this latter phenomenon a sample of webbing was folded perpendicular to its length and then struck repeated blows with a hammer along the fold while lying on an anvil. Beating was continued until the webbing separated. The resulting fibre failure morphology is illustrated in 37B(1).

Plate 37B — Laboratory tests of automobile seat-belt webbing (continued).

(1) Nylon filament from webbing broken by repeated pinching between a hammer and an anvil. (2) Nylon filament from webbing failed in tension after 300 hours exposure to ultraviolet radiation. (3) Polyester filament from webbing cut with a knife. (4) Nylon filament from webbing cut with a scalpel. (5) Nylon filament from webbing cut with scissors. (6) Polyester filament from webbing cut with tin snips (metal shears).

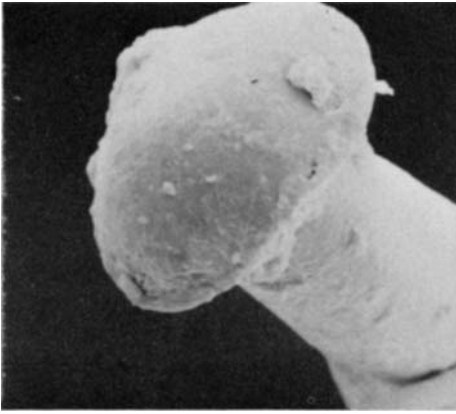
1

The first pictures are from the driver's seat-belt webbing in a vehicle which skidded sideways into the rear of a parked vehicle. Extensive damage occurred to the driver's side (left-hand side) of the skidding vehicle, the maximum intrusion into the vehicle in this region being 38 cm. Examination of both the macroscopic and microscopic appearance of the separated webbing indicated that failure was due to a combination of tensile loading and cutting of the webbing by intruding sheet metal edges which resulted from the collision. Two representative failure morphologies found in the webbing are presented. The fibre shown in 37C(1) has an appearance typical of many fibres in this sample. Mushroom end failures such as this are a consequence of tensile overload. The failure morphology exhibited by the fibre illustrated in 37C(2) shows distinct evidence of a shearing action consistent with the fibre being pulled across a metal edge, and may be compared with 37A(5).

(1),(2) Failed polyester fibres from the broken webbing.

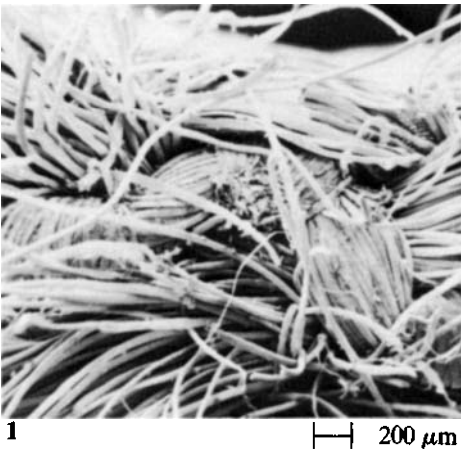
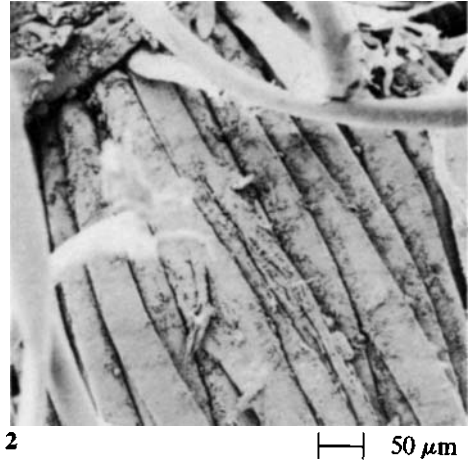
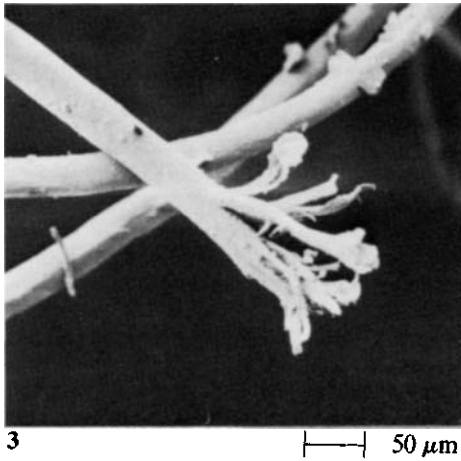
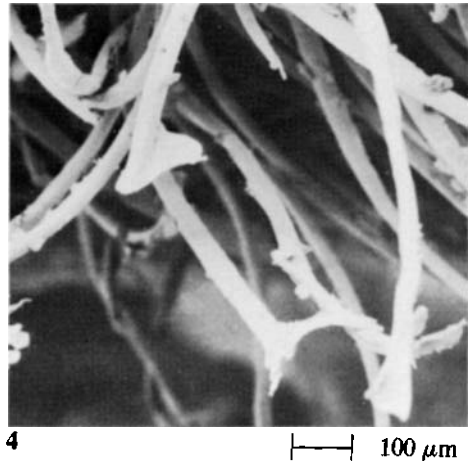
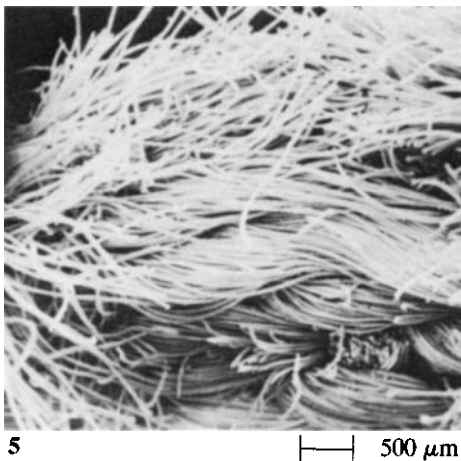
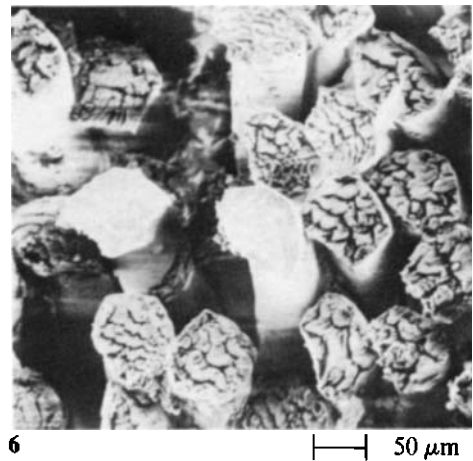
Plate 38A — Worn nylon strap from Jaguar aircraft ejector seat.

The first example is the retraction strap of the ejector seat on a Jaguar aircraft. This was a continuous-filament nylon woven webbing, but had developed a hairy surface owing to projecting loops and broken filaments. Wear was particularly severe on the inner curved edge of the strap, and was probably associated with friction between the strap and the clip through which it slides.

Broken yarns at the badly worn edge of the strap are shown in **38A(1)**. The early stages of filament breakdown suggest a combination of multiple splitting due to flexing and peeling caused by surface shear, **38A(2)**. Some broken fibres have bushy ends, **38A(3)**, which could be due to biaxial rotation fatigue (Chapter 13), but the absence of indications of twist suggest that simple flex fatigue (Chapter 12) may be the cause. Alternatively, other filaments have flattened and mangled ends, **38A(4)**, presumably due to a shearing or cutting under high normal loads from the guide.

Where weft yarns have been severed, they shrink back into the fabric, **38A(5)**. Examination of broken filaments, **38A(6)**, shows flat ends which are sheared in one direction and subdivided into many zones. This suggests that they had first split and then been sheared off or, less likely, been gradually worn smooth.

(1) Severely worn yarns at edge of strap. (2) Detail of badly worn area. (3),(4) Broken filaments from worn area. (5) Several yarns: note broken end of yarn pulled back into fabric, near bottom right corner. (6) Detail of broken yarn.

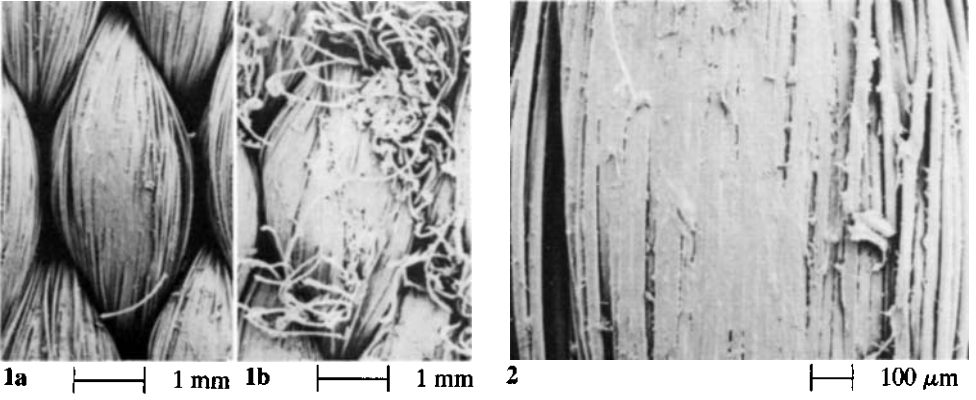
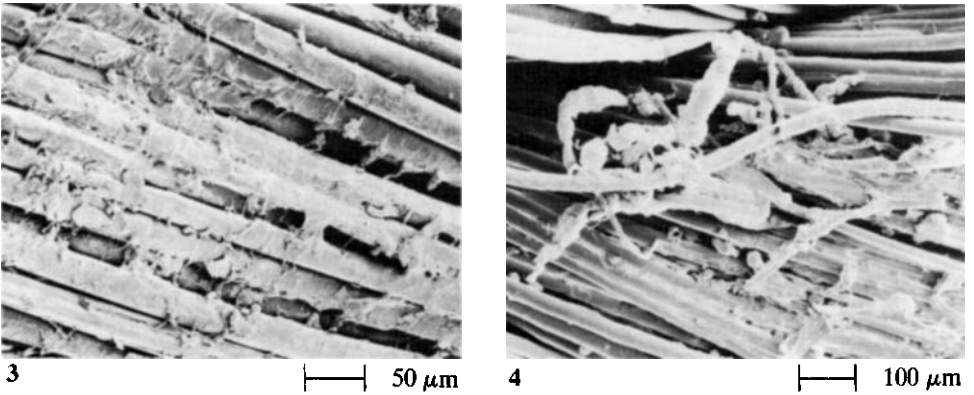
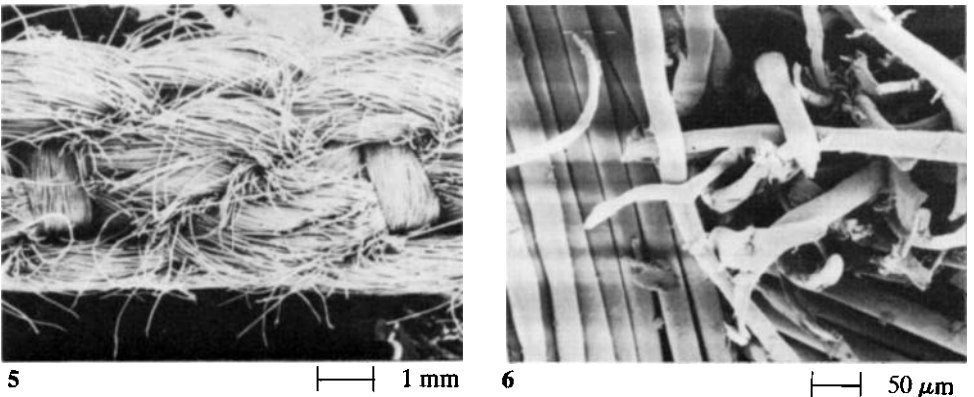
Plate 38B — Nylon arrester harness used on concrete runway.

The second set of examples result from a very different wear environment: they are webbings from arrester harnesses on airfields. Detailed study showed interesting differences between different parts of the webbings, but only some common features will be described here. Surprisingly, webbing which had been used for 12 months on a concrete surface, **38B(1a)**, showed less damage than one which had been used for only 4 days, **38B(1b)**. This presumably reflects the irregular usage of such equipment. The comparatively minor wear after long use occurs on the yarn crowns, where there is a smearing over the surface, **38B(2)**, as a result of material being peeled off, **38B(3)**. The peeling action on the 4-day specimen is more drastic, **38B(4)**, giving a very ragged appearance with some material rolled up. Other regions of the webbing are hairy owing to filament breakage, **38B(5)**, with evidence of multiple splitting, **38B(6)**.

(1a) Surface after use for 12 months. (1b) Surface of another webbing after use for 4 days. (2), (3) Wear on 12-month specimen. (4) Wear on 4-day specimen. (5),(6) Selvedge region of the 12-month specimen.

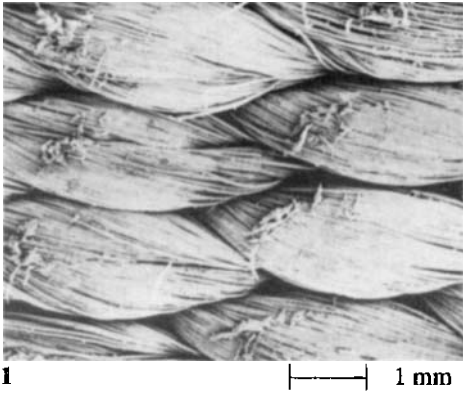
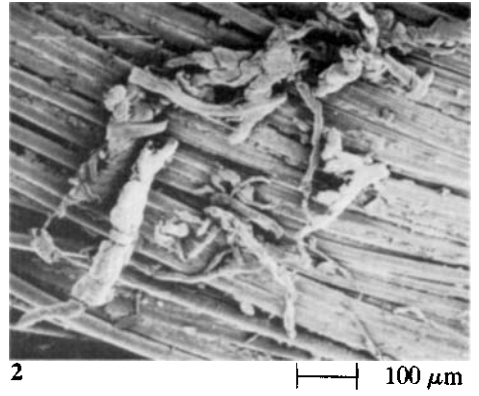
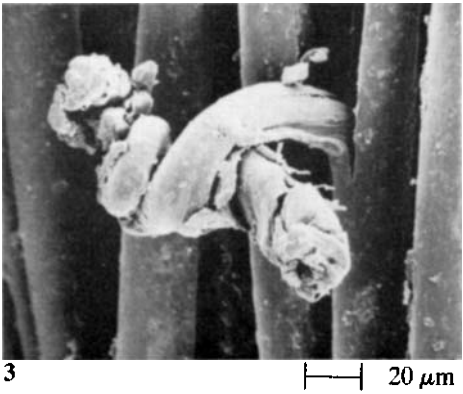
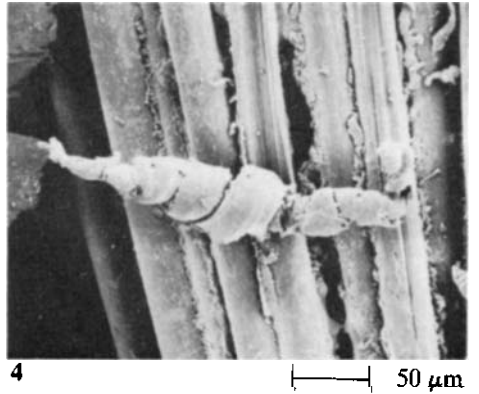
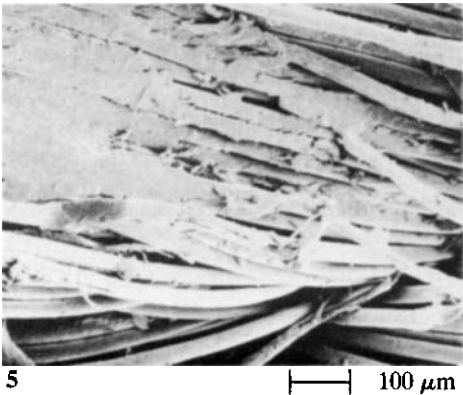
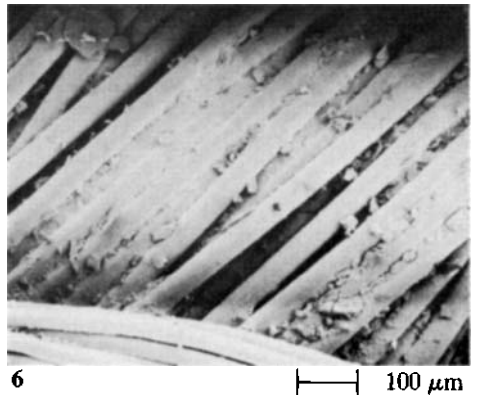
Plate 38C — Nylon arrester harness used on farmac for 12 months.

Webbing which had been used for 12 months on a tarmac surface had also been scraped and smeared, **38C(1)**, with some material being rolled up, **38C(2)**. Detailed views show how a substantial part of a filament can split off and roll up, **38C(3),(4)**. Other parts of the webbing showed less severe damage by smearing, **38C(5)**, or an absence of wear but considerable contamination by debris, **38C(6)**.

(1),(2) Wear on surface. (3),(4) Detail of fibre damage. (5),(6) Other parts of the webbing.

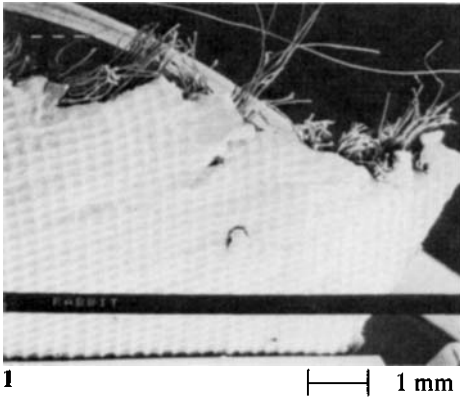
Plate 38D — Nylon arrester barrier centre marker damaged by rabbits.

Equipment used on airfields suffers damage not only through general mechanical wear and environmental degradation and emergency overloads, but also through extraneous causes. For example, **38D(1)** shows an arrester barrier centre marker after it had been damaged by rabbits. The teeth marks can be seen in the plastic-coated fabric. Where the material has been bitten through, **38D(2)**, the fibre ends are flattened into a spatula shape, **38D(3)**. Other fibres show damage over a greater length, **38D(4)**, and were probably broken by abrasive action, rather than being directly cut by the action of the teeth.

(1) General view. (2) Detail of bite. (3) Fibre end from bite. (4) Other broken fibres.

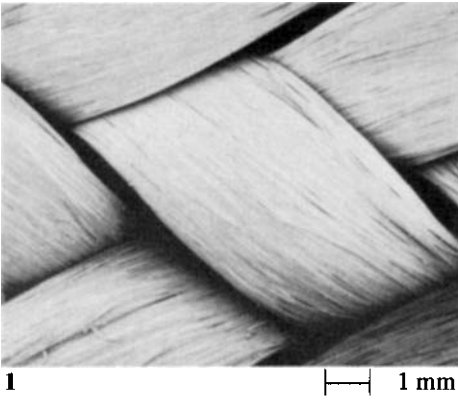
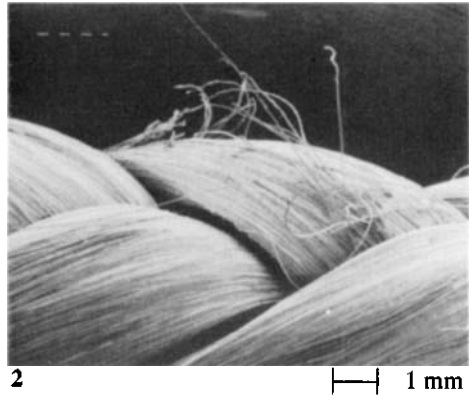
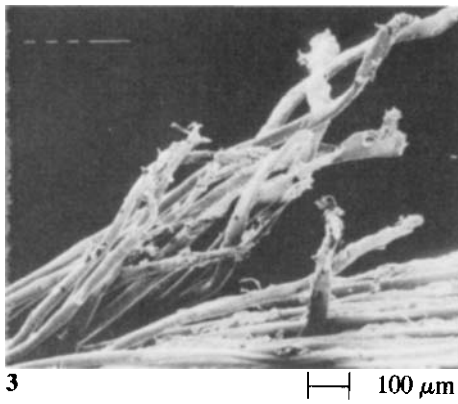
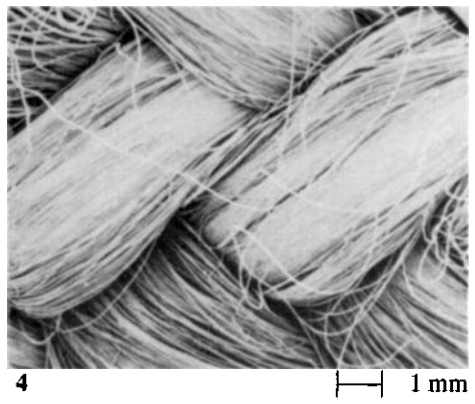
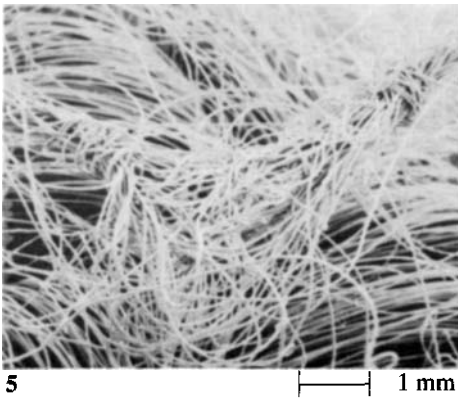
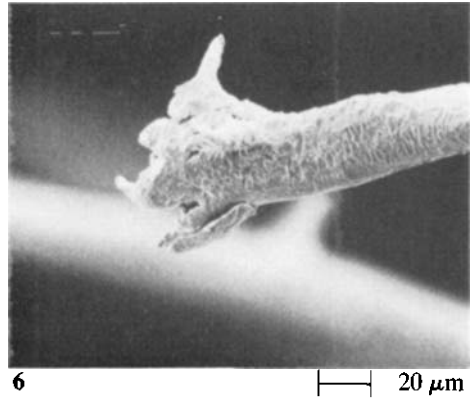
Plate 38E — Nylon border cords from helicopter cargo nets.

has flattened into a webbing about 8 mm thick. The surface of the cord had been treated with a dark grey coating, which held the filaments together. One sample had only very slight damage, as can be seen from the appearance of the surface, **38E(1)**, although there are a few broken filaments on the edges of the cord, **38E(2),(3)**. The flattened and distorted appearance of the filaments indicates that breakage was due to heavy lateral pressure. The second sample was much more severely worn, and the colour had changed from dark grey to a light silver. The surface of the cord is badly disturbed, **38E(4)**, and on one edge the filaments were twisted and tangled, **38E(5)**. The fibre breakage, **38E(6)**, again appeared to result from the lateral pressure.

(1) Main surface of little-worn cord. (2) Edge of little-worn cord. (3) Detail of fibre breakage. (4) Main surface of severely worn cord. (5) Edge of severely worn cord. (6) Detail of fibre breakage.

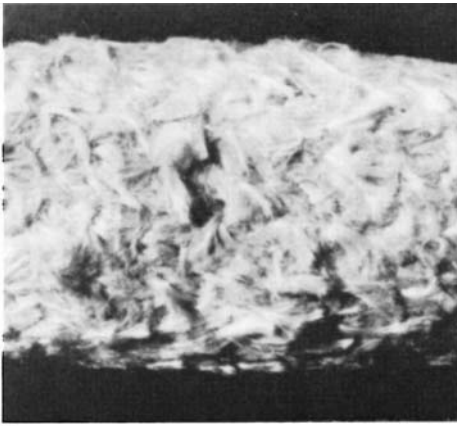
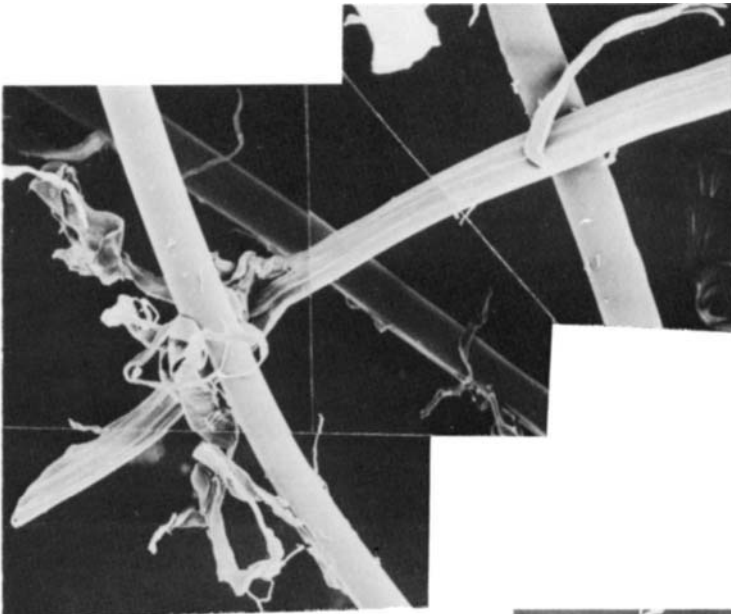
Plate 39A — Nylon rope cycled wet up to a load of 50% of breaking load, failed after 970 cycles: piece of rope away from break (from OCIMF test).

As an example, taken from OCIMF tests, **39A(1)** shows a large nylon rope which had broken after being cycled wet between a low load and 50% of its single-test breaking load: under the repetitive loading the rope lasted for only 970 cycles. A polyester rope would have lasted for millions of cycles at this loading, and would have needed a loading of around 90% of its normal breaking load to fail in less than 1000 cycles. In the nylon rope the original continuous filaments had broken down into short fibres, as a result of a splitting and peeling shown for a collection of fibres in **39A(2)** and in more detail in **39A(3)–(6)**.

(1) General view of rope. Note that the rope before testing had a smooth continuous-filament surface, whereas the cycled rope shows many fibre ends sticking out. (2) Broken fibres in inner core region. (3) Detail of fibre splitting and peeling in inner core. (4)–(6) Detail of splitting and peeling in fibres from outer braid.

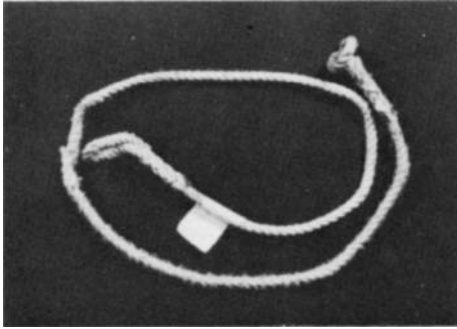
Plate 39B — Nylon rope after use in securing the skirt to the bow of a hovercraft.

A length of the nylon rope, removed because it was near to failing, is shown in **39B(1)**. Some parts of the rope were almost undamaged, **39B(2a)**, apart from slight surface rubbing, a few broken filaments and some contamination with dirt; other parts showed clear evidence of moderate wear, **39B(2b)**; and near the knot in the eyelet of the skirt, the rope had almost broken, **39B(2c)**.

(1) The complete rope assembly, which was knotted through an eyelet at the region of severe damage in the middle of the rope on the left. (2) Rope surface in a macrophotograph: (a) region of little damage; (b) region of moderate damage; (c) knot region, with severe damage. (3) Surface of rope in region of little damage. (4) Broken filament in region of little damage. (5) Broken filament in region of moderate damage. (6) Start of fibre peeling in region of moderate damage.

The next example comes from a failure in use of a rope, which was then subjected to very detailed examination. The rope was a nylon rope which was used to tie the skirt of a hovercraft onto the vessel itself. Failure was occurring after a short period of use, and it was found that the problem was that a cheaper nylon rope had been substituted for the previously used polyester rope. A return to the earlier practice solved the problem.

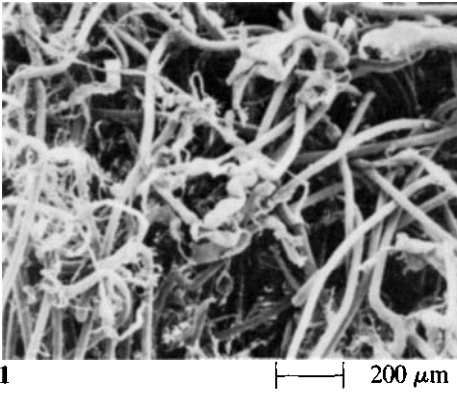
Plate 39C — Hovercraft rope (continued).

(1) Surface of rope in region of severe damage. (2) Rope in least-damaged region, opened out for examination of inter-strand damage. (3)–(6) Detail of the inter-strand damage in this region.

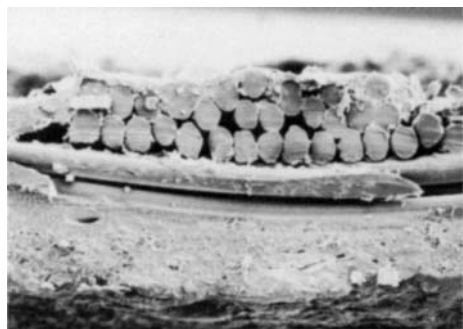
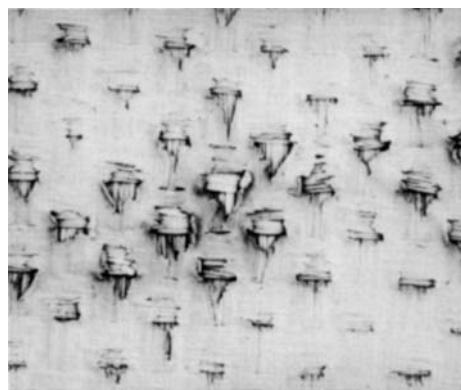
Plate 40A — Examination of worn wind-cone.

(1) Cross-section of relatively undamaged material. (2) Cross-section showing initial indication of damage. (3) First signs of break-up of coating. (4) Specimen folded into a V-bend, showing large areas of loss of bonding between fabric and coating. (5) First signs of damage on the face of the material. (6) More severe damage on the reverse side.

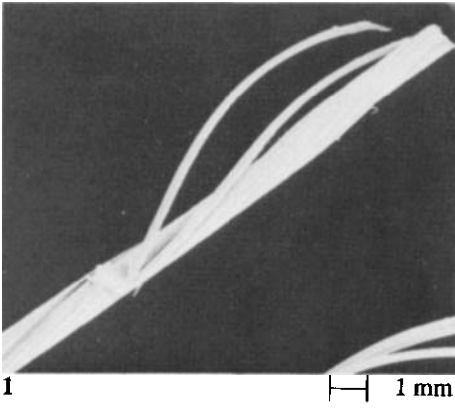
Plate 40E — Broken string of badminton racket.

(1) General view of break. (2) Cross-over point of strings. (3) Peeling on string surface, due to general wear at centre of racket. (4)–(6) Detail of break.

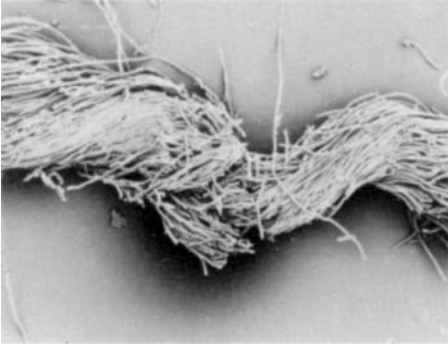
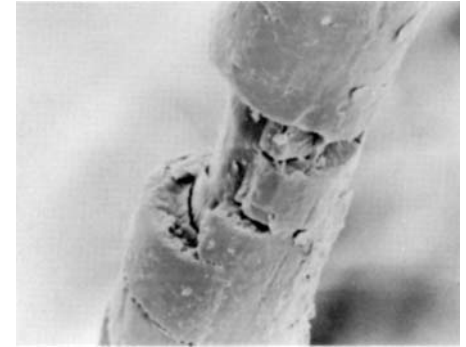
Plate 40K — A degraded polypropylene filter.

Filter fabrics can suffer damage from chemical and thermal attack as well as mechanical action. The pictures in **40K** are of a degraded polypropylene filter after use at 110°C. The yarn break in **40K(1)** can be seen in **40K(2)** to include a mixture of stake-and-socket breaks, which, as shown in **16D(1)**, are common after chemical attack, and axial splitting. In other places, **40K(3)**, the fibres break into short pieces. Earlier stages of the thermal and chemical attack are shown in **40K(4)–(6)**. Extensive transverse cracking leads to portions of material breaking away.

(1) Yarn breaking. (2) Details of fibre breaks. (3) General damage. (4) Transverse cracks and pieces breaking off.

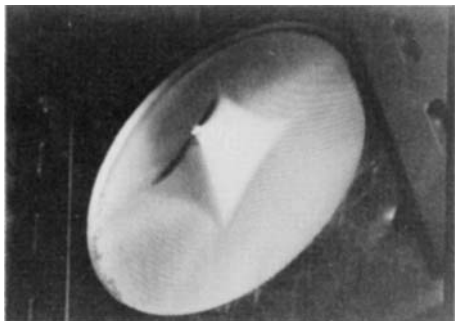
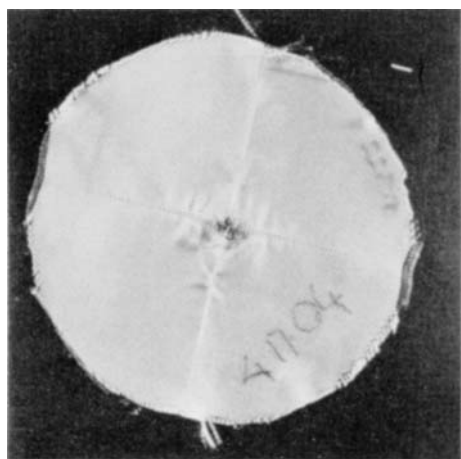
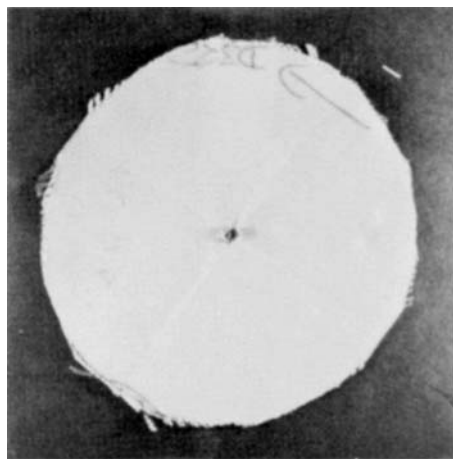
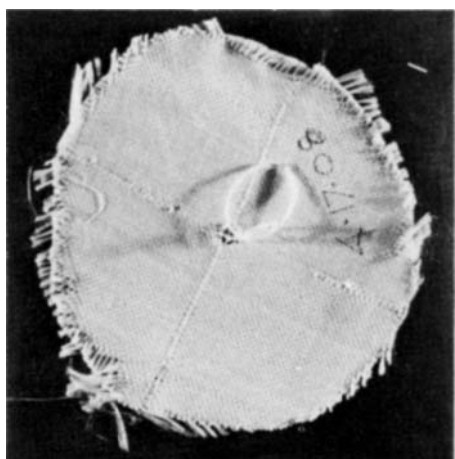
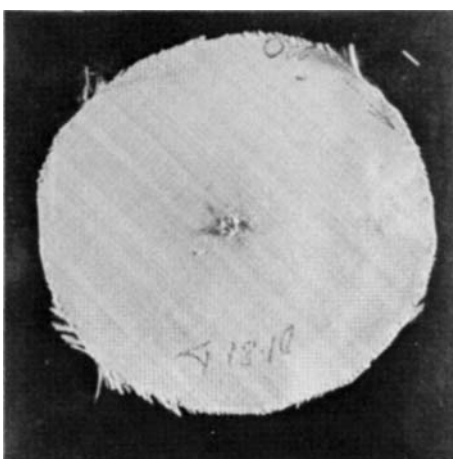
Plate 40L — Ballistic impact.

The rupture of nylon and Kevlar fibres as a result of ballistic impact are shown in **40H(5),(6)**, but in view of the limited information on the form of damage by bullets, as referred to in Chapters 44 and 46, it is worth including more pictures from the laboratory studies of C. Cork at UMIST. When a bullet impacts at high speed on a woven fabric, a pyramidal out-of-plane wave propagates across the specimen, **40L(1)**, preceded by an in-plane wave, which contributes to the increase in length. In a more isotropic knit fabric, **40L(2)**, the deformation is conical. After a nylon fabric has been penetrated at the comparatively slow speed of 254 m/s, **40L(3)**, there is extensive local damage around the hole made by the bullet and the effects of the in-plane extension along the warp and weft directions can be seen reaching to the edge of the fabric specimen. At the higher speed of 514 m/s, **40L(4)**, the hole is much sharper and the warp and weft deformation lines do not extend as far, because penetration has been completed before the wave reaches the edge of the circle. Similar differences are seen in a Kevlar fabric, **40L(5),(6)**.
