***Part X***  
***Medical applications***

## FAILURE IN ANTERIOR CRUCIATE LIGAMENTS

**Plate 48A — ABC anterior cruciate ligament (ACL).**

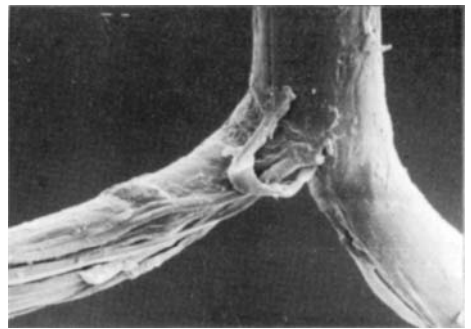
Long axial splits, **48B(3)**, were frequently observed for early failures. Closer examination of the same filament revealed splitting and fibrillation within the main body of the filament, **48B(4)**. This internal splitting of a filament, **48B(5)**, creates points of weakness resulting in a fibrillated rupture **48B(6)**.

(1) Flattened filaments: RO. (2) Crushed filament: DF. (3),(4) Filament with an axial split at low and high magnification: TE. (5),(6) Internal splitting and fibrillation in a filament from another ligament.

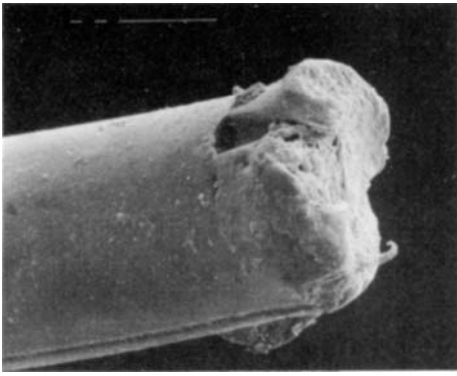
1

Tensile breaks, **48C(1)**, were identified from material from six ligaments. However, tensile breaks were always a secondary fracture morphology. For example, with the ligament shown in **48A(7)**, the three projecting strands of material at one edge were found to have failed with tensile breaks as opposed to the remainder of the ligament, which failed with crushing and flattening. This pattern of fracture morphologies unambiguously demonstrated that rupture of the ligament was not the result of insufficient tensile strength for, if this was the case, the tensile breaks would have been present right across the ligament. Instead, failure was the result of focused mechanical damage working its way across the ligament until the last three strands were overloaded and failed with tensile breaks.

(1) Tensile break: BO. (2) Surface peeling: SI. (3) Tissue adhesion with possible peeling: SI. (4) Layered surface peeling: BB. (5),(6) Possible tensile fatigue: HA.

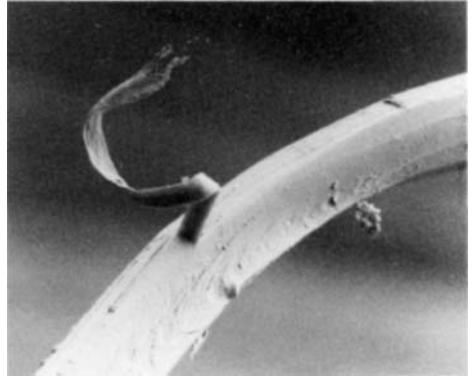
2

Some surface peeling, **48C(2)**, was identified to a greater or lesser degree in all the explanted prostheses. In general this is due to surface shear forces resulting from a lateral pressure on the prosthesis, although there is an indication that some surface peeling could result from adhesion between tissue ingrowth and the surface skin of the polyester filament, **48C(3)**. In an extreme form, the surface peeling can act layer by layer deeper into the filament, **48C(4)**. This layered surface peeling was noted at the level of the exit to the tibial drill hole for a prosthesis which had not ruptured but which had been explanted because of a reaction against wear debris released into the knee joint.

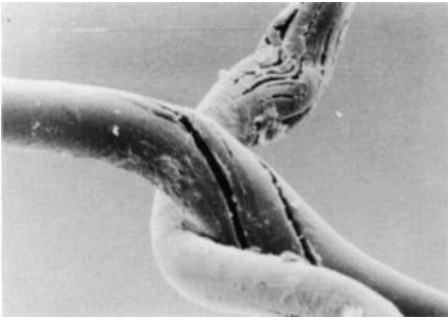
1

For the group of ABC prosthetic ligaments which failed between two and four years after implantation, the fracture morphology identified to a greater or lesser degree on a majority of the implants was multiple splitting fatigue, **48D(1)**. The fatigue damage was not present throughout the ligament, but was isolated at the point of rupture. It has however, not been possible to establish whether or not the fatigue damage was the cause of the rupture or a result of the significant time lapse between the rupture and the explantation of the prosthesis. Both of the polyester filaments shown in **48D(1)** have fatigue damage with the more horizontal of the filaments having transverse splits indicating biaxial rotation compared to the more axially orientated splits of the other filament which indicates flexural fatigue.

(1) Multiple splitting: JO. (2) Multiple splitting and resulting breaks: LA. (3) Rounded end: LE. (4),(5) Kink bands combined with multiple splitting: DI. (6) Kink bands opening into cracks: BE.

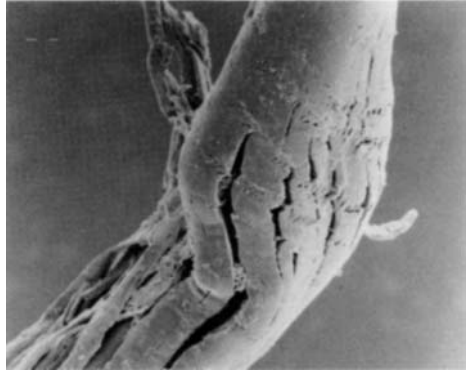
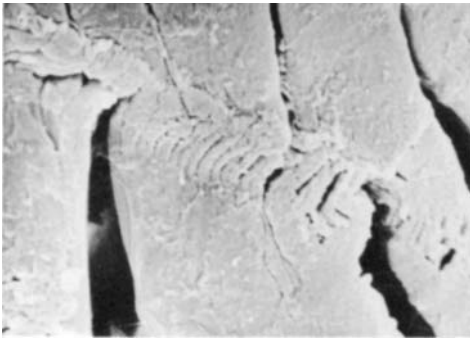
Multiple splitting fatigue was also identified in association with kink bands such as shown in **48D(4)**. The cracks of the multiple splitting fatigue can clearly be seen to start from a kink band split, **48D(5)**, and then follow a line of weakness from one line of kink bands to the next, changing direction slightly at each band. Kink bands were also identified on their own as developing bands and as bands opening into cracks, **48D(6)**.

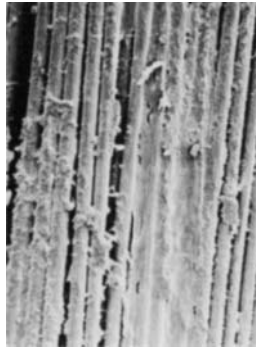
2

Away from the point of rupture, there is occasional evidence of surface peeling from inter-filament abrasion but the vast majority of the artificial material is undamaged. The undamaged polyester, 48E(1), and carbon fibre, 48E(2), are from the intra-articular portion of a prosthesis that was implanted for thirty-nine months.

(2) Undamaged carbon fibres from the same region: DI. (3) Carbon fibre break.

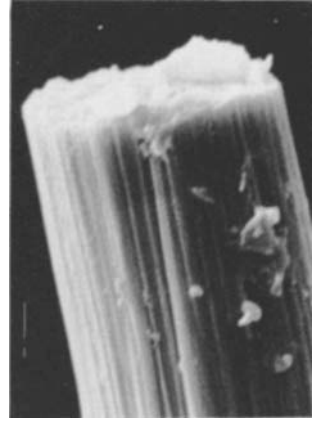
3

The carbon fibres used as the core element in some of the examined prostheses always failed with a brittle tensile break, 48E(3), at the point of rupture of the ligament. This repetitive brittle fracture, irrespective of the nature of the force that caused the rupture of the prosthesis, effectively excluded the carbon fibres from the mode of failure analysis. However, the carbon fibre was examined for any evidence of the fragmentation that has frequently been associated with implanted carbon fibre. No evidence was identified of fragmentation away

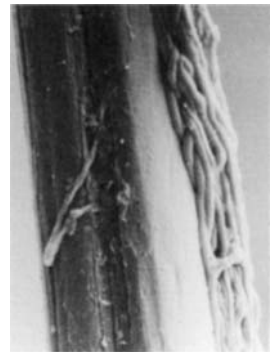
6

An unexpected bonus of the SEM examination of the explanted polyester was the evidence of oriented tissue ingrowth, such as shown in **48E(6)**, in which a network of collagen fibres runs along the polyester filament. The ligament had been implanted for thirty-two months. The braided structure of the ABC prosthesis results in the polyester following the longitudinal axis of the ligament. The orientation of the collagen along the polyester indicates that the collagen will also be oriented along the longitudinal axis of the ligament.

(4) Tissue adhering to carbon fibres. (5) Tissue ingrowth within the prosthesis: SI. (6) Tissue ingrowth along the surface of polyester fibre: TA.

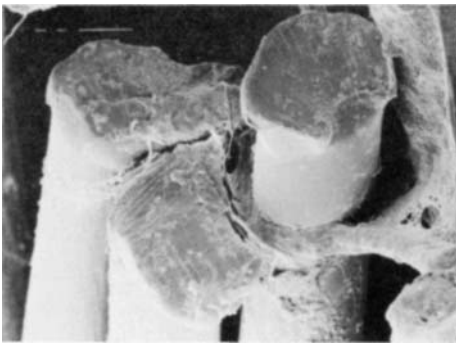
7

The fracture morphology analysis was also able to identify damage that was unrelated to the rupture of the prosthesis. In particular an instance of the polyester having been cut with a scalpel, **48E(7)**, was identified. It is assumed that the cut was made during the explantation operation. The breaks are flat but unlike standard tensile breaks, they are at varying angles and are smeared into each other by the passage of the scalpel blade.

(7) Polyester filaments cut by scalpel: HM.

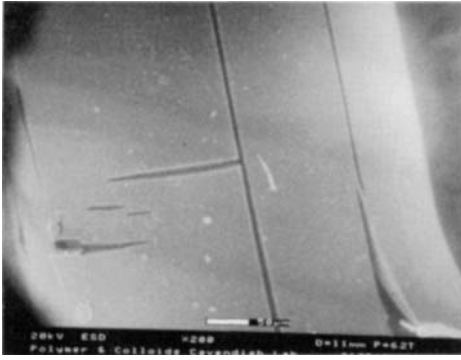
In order to determine the effect of drying on the surface morphology of Maxon, environmental scanning electron microscopy (ESEM) was used. This technique allows wet samples to be studied, thus avoiding harsh sample preparation such as coating or drying. A degraded sample of Maxon was placed in the ESEM and slowly dried by increasing both the temperature and the vacuum. Initially, the sample appeared almost smooth with only a few longitudinal cracks. More severe cracking was seen to happen very rapidly on drying. The result depended on the rate of water removal, and **49C(1),(2)** show two pieces of the same material dried under different conditions.

(1),(2) Two samples dried under different conditions in an environmental SEM.
