Part VII
Case studies:
industrial uses

36

AUTOMOBILE SEAT BELTS

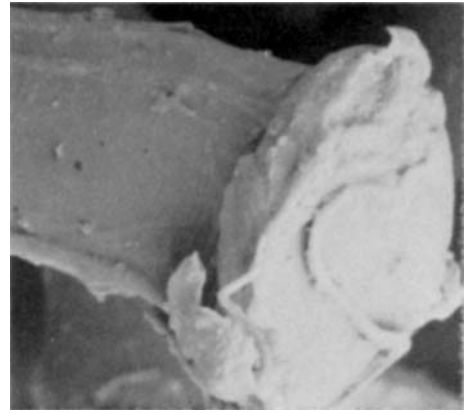
2

Both nylon, 37A(2), and polyester, 37A(3), filaments from webbing specimens failed in a drop test have an appearance similar to that of fibres found in specimens failed in simple tension, although the polyester end is somewhat more bulbous than that found on tension failure specimens. In polyester webbing which had been passed through a D-ring and drop tested, other effects of material melting may have occurred, 37A(4). At some places in the

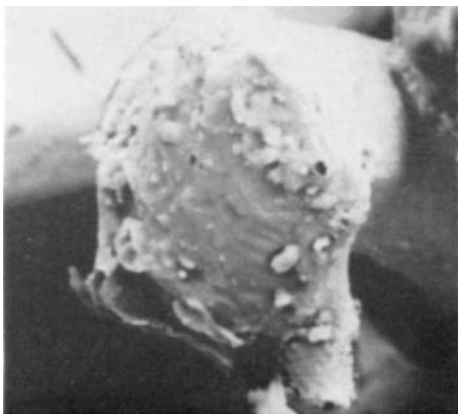
5

webbing several filament ends could be seen to have fused together. A nylon filament, which formed part of a webbing specimen broken in a drop test over a sheet metal edge, is shown in 37A(5). The appearance of polyester filaments fractured in a drop test over a sheet metal edge, 37A(6), is characteristic of this type of failure mode. A similar appearance is found in some nylon fibres in webbing failed in this manner.

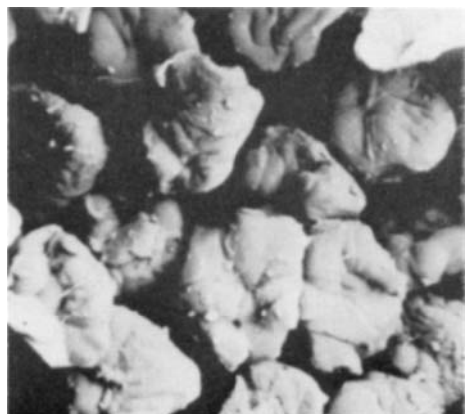
6

(6) Polyester filament from webbing broken in drop test over sheet metal edge.

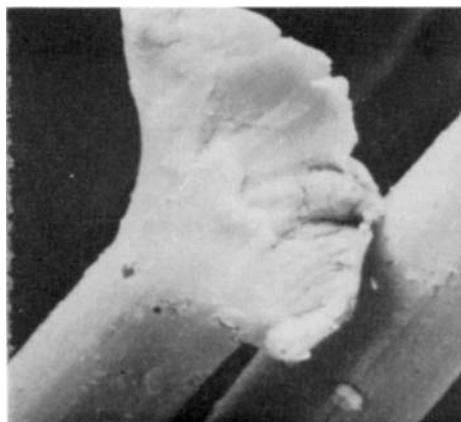
3 |—| 10 μm

On occasion, webbing is deliberately cut by rescue personnel, and it is important to be able to identify webbing which has been separated in this manner. A polyester filament in a webbing specimen cut with a pocket knife, 37B(3), has a fan-like appearance. This effect is typical of a knife cut, and is seen in nylon as well as polyester webbing. A sharply defined flat surface is found in a nylon filament from a webbing cut with a scalpel blade, 37B(4). The striations on the surface correspond to fine grinding marks on the blade. The fracture morphology in the nylon fibre, 37B(5), is typical of that produced by a scissor cut of webbing. Polyester filaments exhibit a similar form. Not all scissor cuts produced this appearance; some were more like the fibres illustrated in 37B(6), which is a polyester filament from a webbing cut by tin snips (metal shears). Note that there is no evidence of pinching, as is seen in other examples of scissor cuts. This form of failure appears in both nylon and polyester webbing.

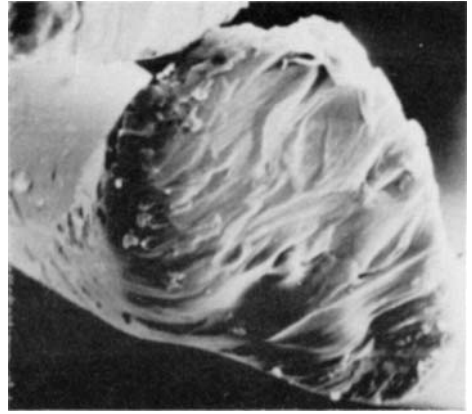
2

The first pictures are from the driver's seat-belt webbing in a vehicle which skidded sideways into the rear of a parked vehicle. Extensive damage occurred to the driver's side (left-hand side) of the skidding vehicle, the maximum intrusion into the vehicle in this region being 38 cm. Examination of both the macroscopic and microscopic appearance of the separated webbing indicated that failure was due to a combination of tensile loading and cutting of the webbing by intruding sheet metal edges which resulted from the collision. Two representative failure morphologies found in the webbing are presented. The fibre shown in 37C(1) has an appearance typical of many fibres in this sample. Mushroom end failures such as this are a consequence of tensile overload. The failure morphology exhibited by the fibre illustrated in 37C(2) shows distinct evidence of a shearing action consistent with the fibre being pulled across a metal edge, and may be compared with 37A(5).

Plate 37C — Seat belt from a skidding accident.

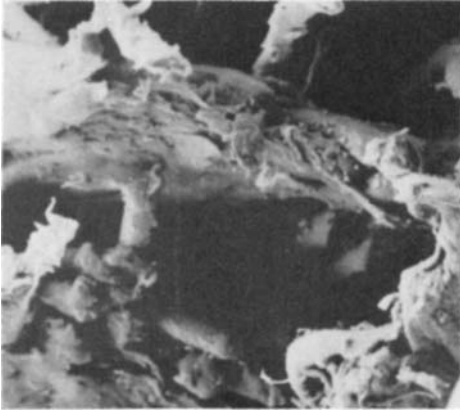
1

Plate 37D — Seat belt from a high-speed roll-over collision.

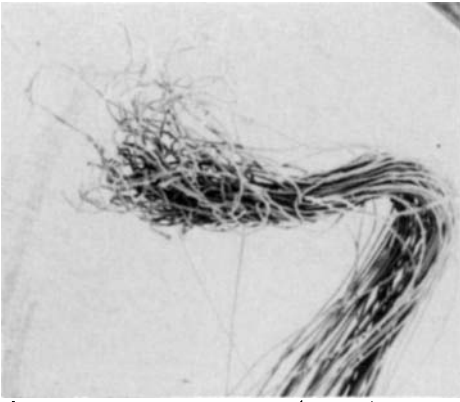
1 | 1 mm

Plate 38E — Nylon border cords from helicopter cargo nets.

(1) Main surface of little-worn cord. (2) Edge of little-worn cord. (3) Detail of fibre breakage. (4) Main surface of severely worn cord. (5) Edge of severely worn cord. (6) Detail of fibre breakage.

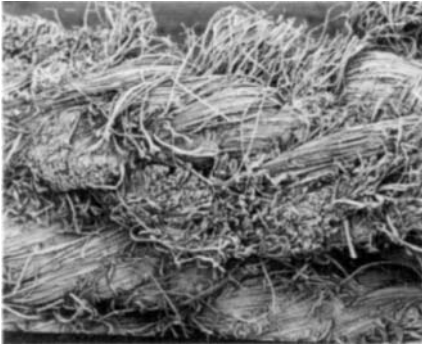
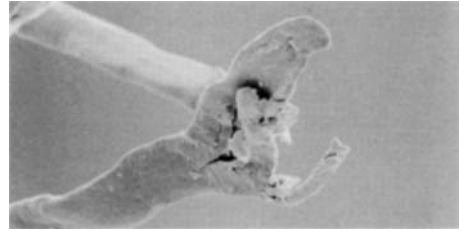
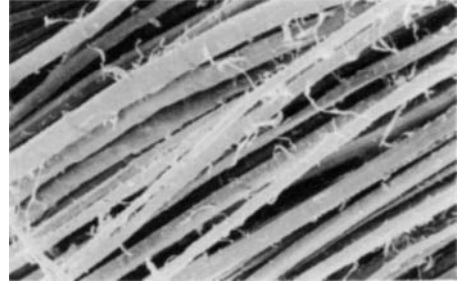
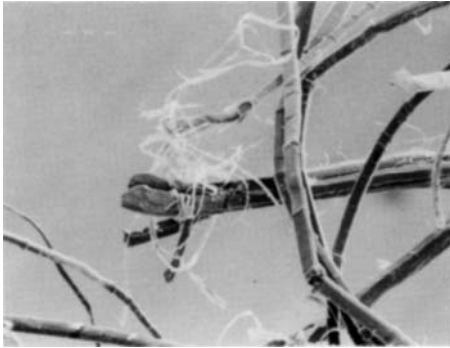
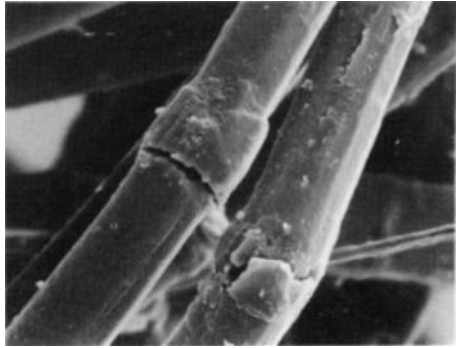
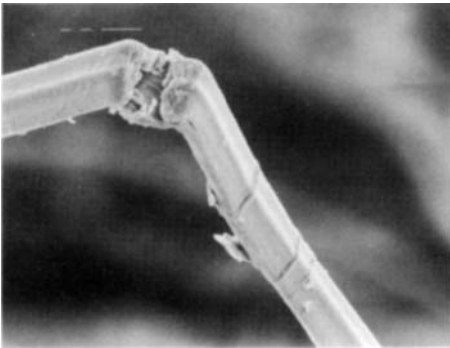
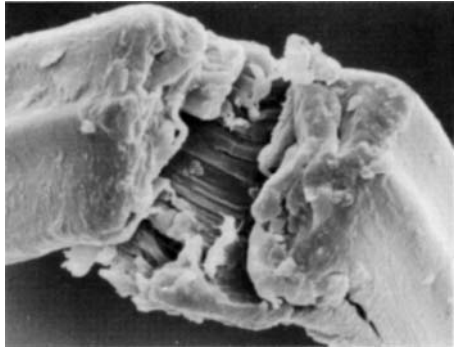
Plate 38G — Wear of flax restraint webbings.

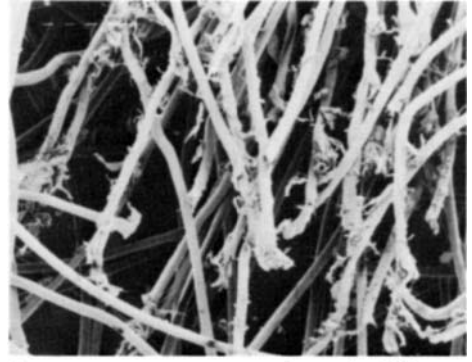
1

Plate 39A — Nylon rope cycled wet up to a load of 50% of breaking load, failed after 970 cycles: piece of rope away from break (from OCIMF test).

(1) General view of rope. Note that the rope before testing had a smooth continuous-filament surface, whereas the cycled rope shows many fibre ends sticking out. (2) Broken fibres in inner core region. (3) Detail of fibre splitting and peeling in inner core. (4)–(6) Detail of splitting and peeling in fibres from outer braid.

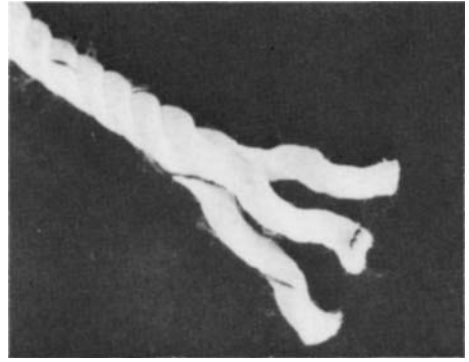
2

(1) Surface of rope in region of severe damage. (2) Rope in least-damaged region, opened out for examination of inter-strand damage. (3)–(6) Detail of the inter-strand damage in this region.

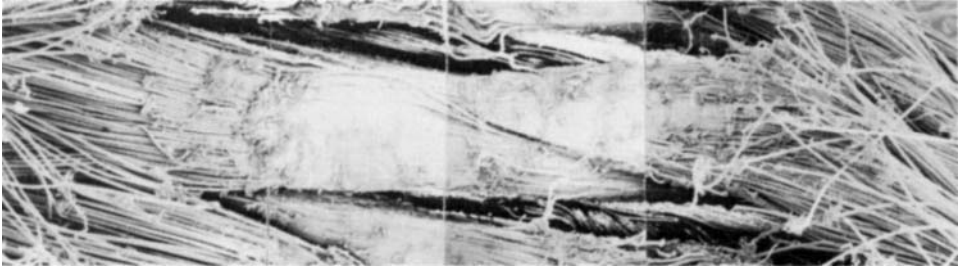
1 | 500 μm

(1) Inter-strand wear in region of moderate damage. (2),(3) Detail of fibre breakdown in this region.

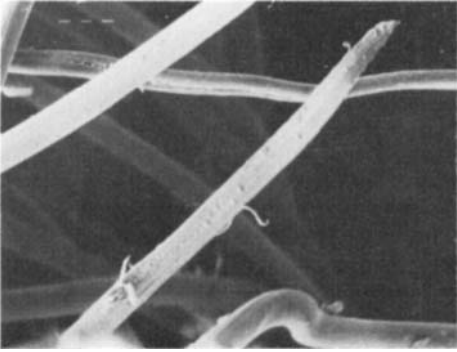
5 | 50 μm

(4)–(6) Fibres from region of severe damage near the knot.

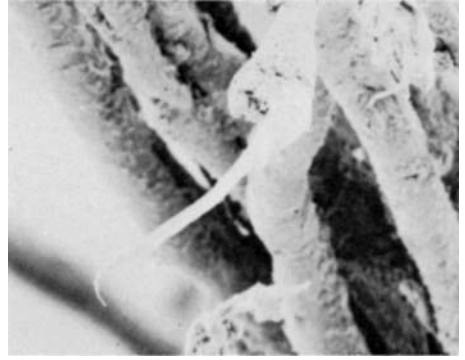
2

(1) Strands away from break in two ropes. (2), (3) Fibre breaks in first rope. (4), (5) Fibre surface changes in first rope. (6) Fibre from second rope.

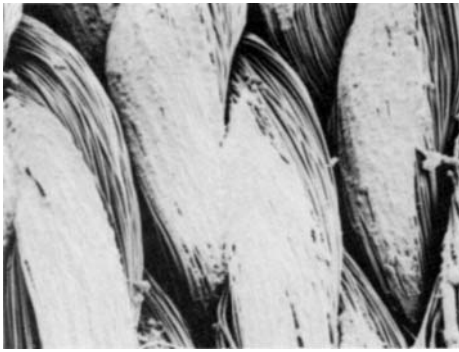
1 | 500 μm

(1) Surface of unbroken strand in rope broken at room temperature. (2) Surface of broken strand in rope broken at room temperature. (3) Broken inner yarn from rope broken at room temperature. (4) Fibre end from this broken yarn. (5) Fibre end from broken yarn in rope broken hot. (6) From broken outer yarn in rope broken at room temperature.

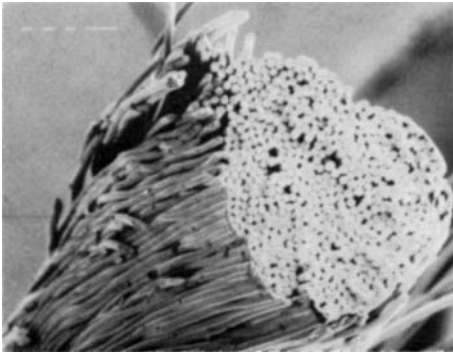
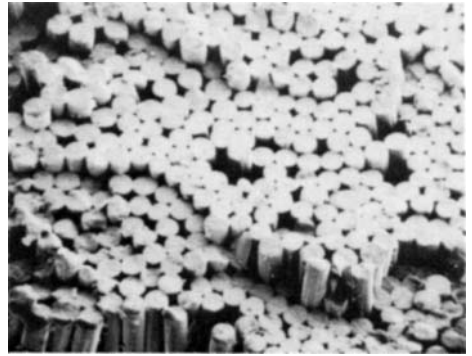
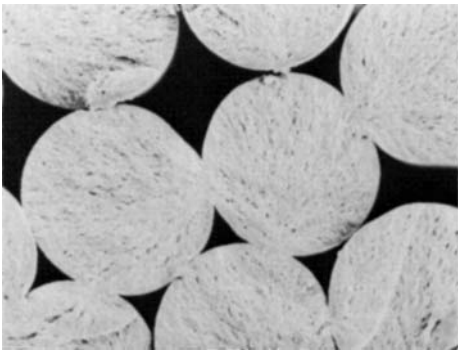
Plate 39H — Nylon 6 rope heated to 160°C for 33 hours and then broken in a tensile test.
 (1)–(3) Yarn from rope broken hot. (4),(5) Inner yarn from rope broken at room temperature.
 (6) Filament from outer yarn in rope broken at room temperature.

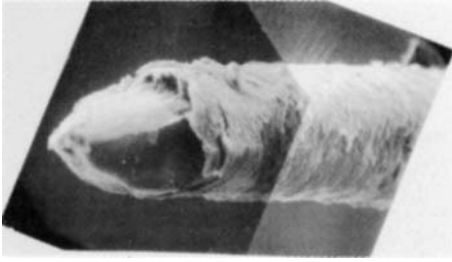
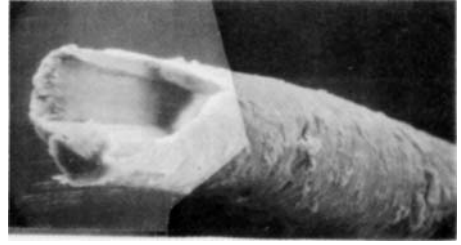
Plate 39J — Damage in a nylon mooring line, by courtesy of S. Backer, MIT.

(1),(2) Opposite ends of a broken filament from a 3-strand nylon rope after several years of use.

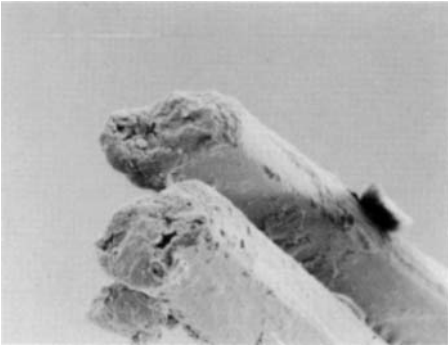
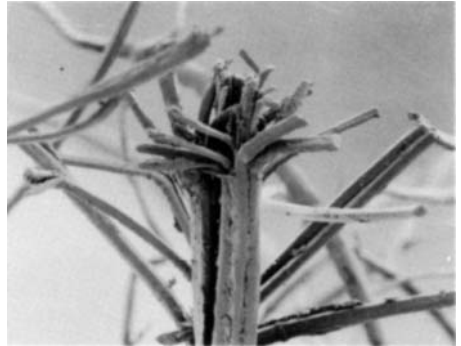
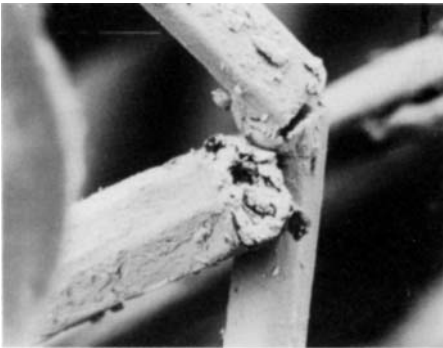
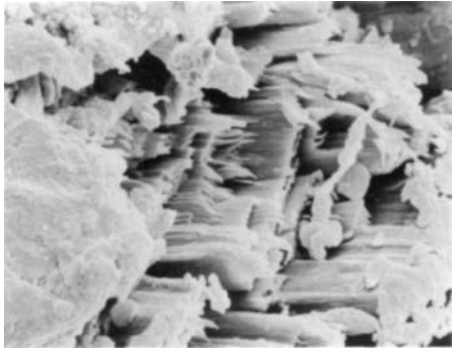
Laboratory break test at RAE of unused flax rope.

(3),(4) Flax fibre rupture. (5) Kink-band failure, possibly on snap-back. (6) Detail of internal rupture of flax fibre.

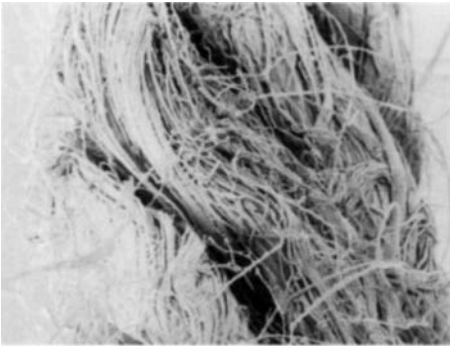
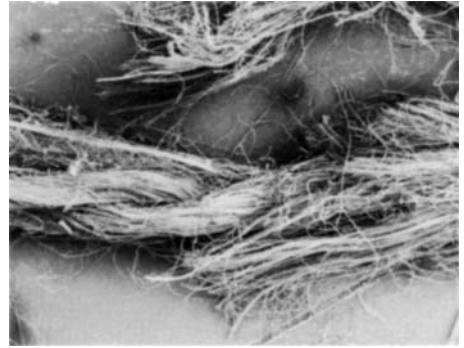
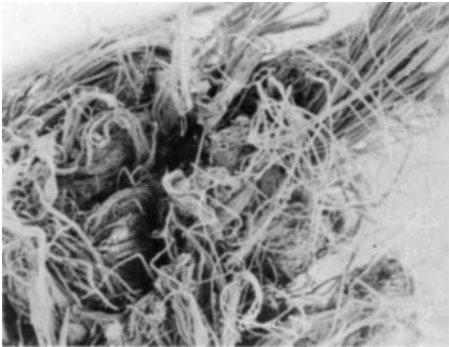
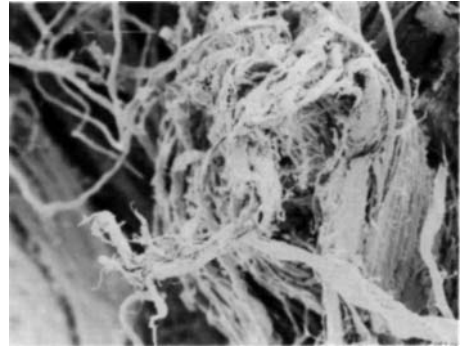
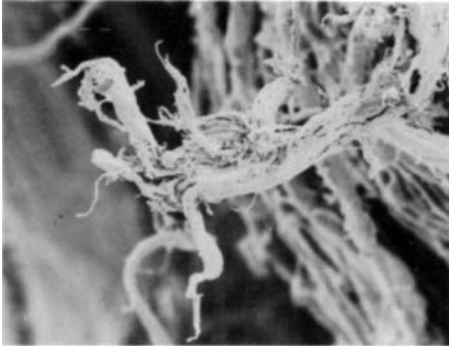
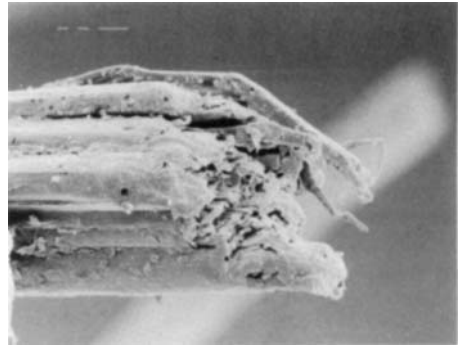
Plate 39K — A worn flax rope from RAE.

(1) External abrasion. (2) Separate strand breaks. (3) Disturbance at strand break. (4)–(6) Fibre breaks.

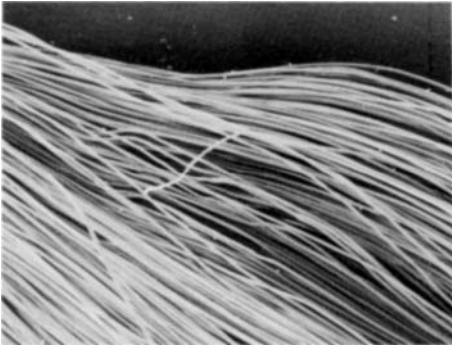
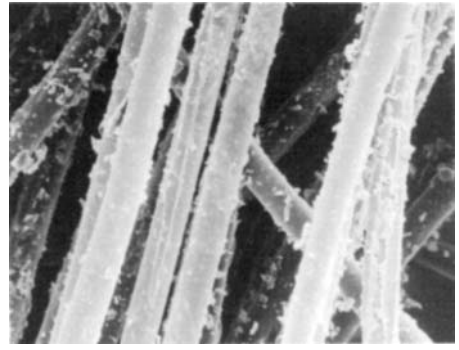
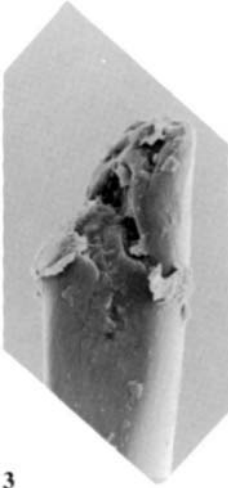
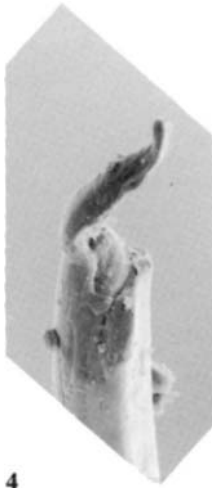
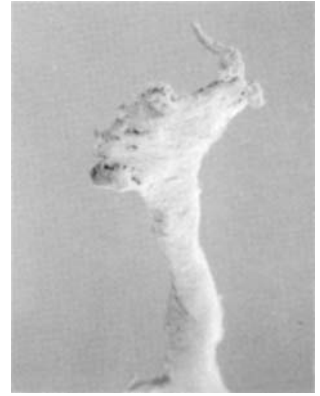
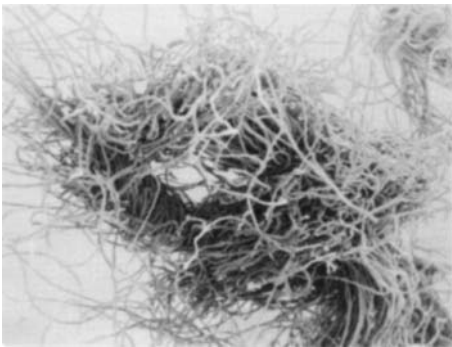
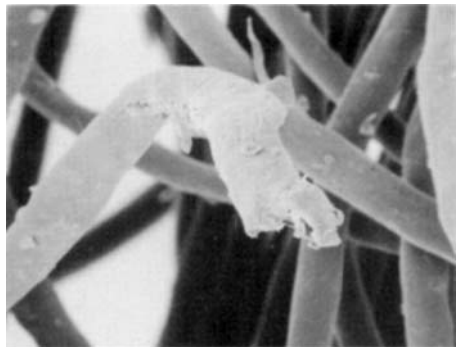
Plate 39L — A polyester multi-strand rope after use in a trial mooring for two years.

(1) Mating point between strands within rope with little damage. (2) Slight peeling and accumulation of debris. (3)–(5) Broken fibre ends. (6) Damaged region of rope jacket. (7) Broken fibre from jacket.

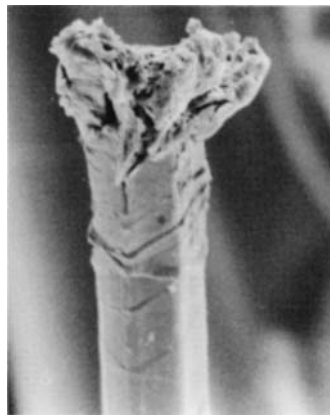
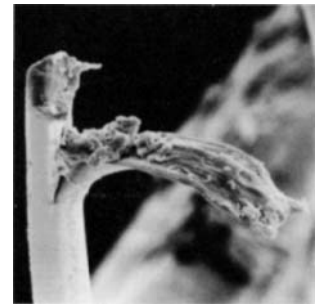
Plate 39M — Five tonne aramid Kevlar 129 rope in a 6-round-1 twisted wire-rope construction after 1000000 cycles tension-tension fatigue between about 10 and 50% of break load (60 kN), centre yarn of core strand.

(1),(2) Broken into pieces between 2.5 and 5 mm long. (3)–(5) Kink-bands within fibres. (6) Kink of whole fibre. (7) Break at kink in fibre. (8)–(15) Fibre breaks, along kink-bands and with axial splitting.

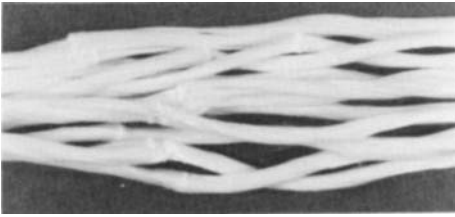
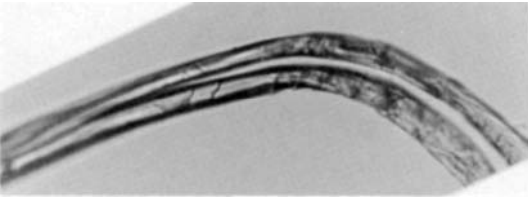
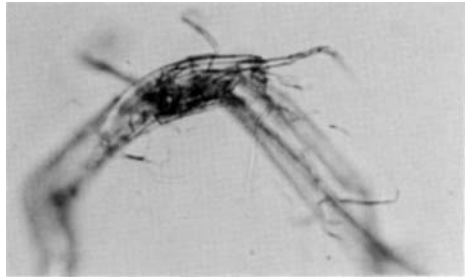
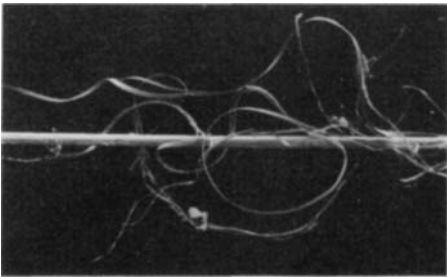
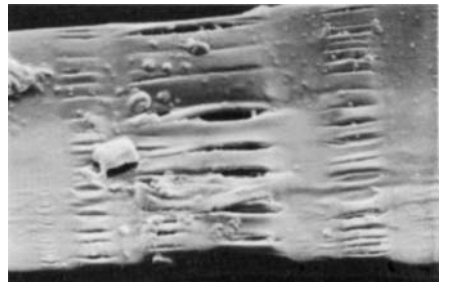
Plate 39N — Five tonne aramid Twaron 1000 ropes, after 1000000 or more cycles of tension-tension cycling between about 20 and 60% of break load.

(1) Kinks in yarns at interval along a yarn. (2) Kink-bands in a fibre. (3) Axial split. (4),(5) Bending into a kink and then to a break. (6) Break with fibrillation. (7) Two kinks. (8) Double kink. (9),(10) Fibrillation and peeling from fibre surface. (11),(12) Squashing of fibre.

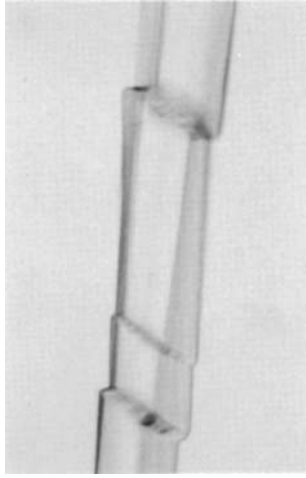
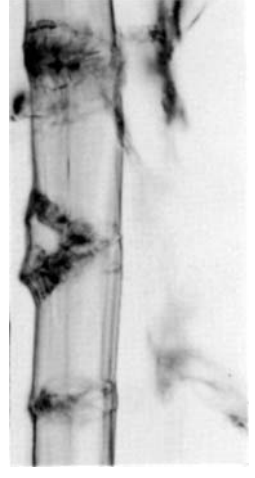
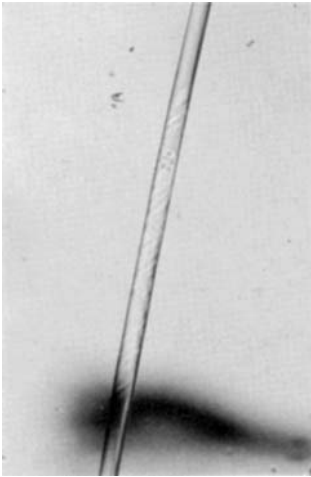
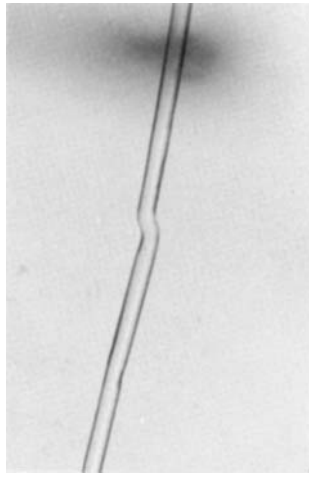
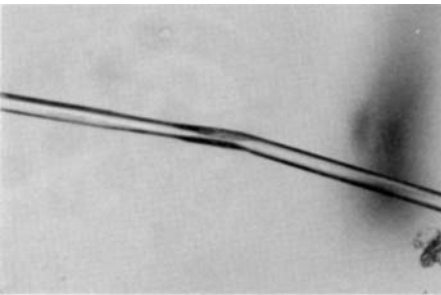
Plate 390 — Five tonne HMPE Dyneema SK60 6-round-1 wire-rope construction after 1080 cycles of tension-tension fatigue between about 10 and 70% of break load had led to failure at the termination. (1) Indications of axial splitting. (2)–(4) Localised kink-bands in the fibre of increasing severity. (5)–(8) Severe kinks in the whole fibre. (9) Kink and break.

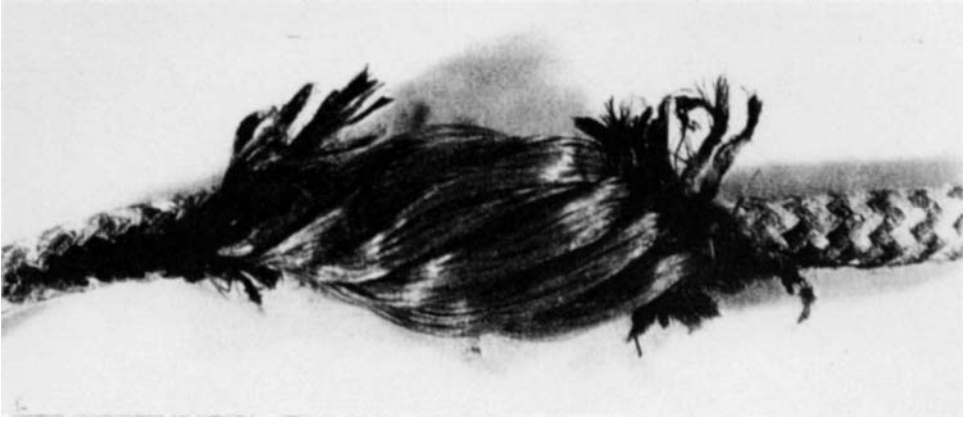
1

(1) A strand with broken jacket. (2) Fibres from an outer layer strand. (3) Fibres from an inner layer strand. (4) Flattening and fibrillation due to excessive transverse pressure.

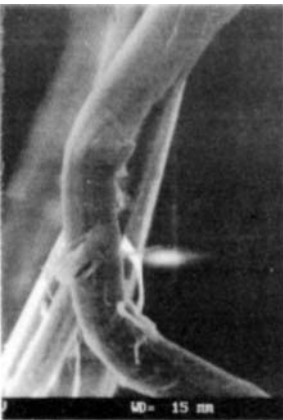
5

(5) From half-jacketed strand tested to failure at 225 kg. (6) From a fully jacketed strand failed at 320 kg. (7) From an unjacketed strand failed at 320 kg.

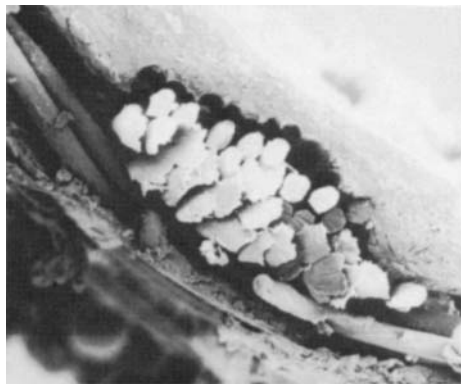
2 |——| 100 μm

In relatively undamaged material, shown in cross-section in **40A(1)**, there is good contact between the nylon yarn and the plastic coating; but the first sign of damage is a separation of coating from the yarn crowns, **40A(2)**. The separations can join up to give long lengths of coating which are no longer bonded to the nylon, although this may not be apparent on superficial examination of the material. Once the coating is loose, it is no longer supported by the strong nylon yarns, and it begins to break up and lift off the surface, **40A(3)**. If the fabric specimen is bent into a V along a line of wear, the depth of separation of coating from the fabric is clearly shown, **40A(4)**.

(1) Cross-section of relatively undamaged material. (2) Cross-section showing initial indication of damage. (3) First signs of break-up of coating. (4) Specimen folded into a V-bend, showing large areas of loss of bonding between fabric and coating. (5) First signs of damage on the face of the material. (6) More severe damage on the reverse side.

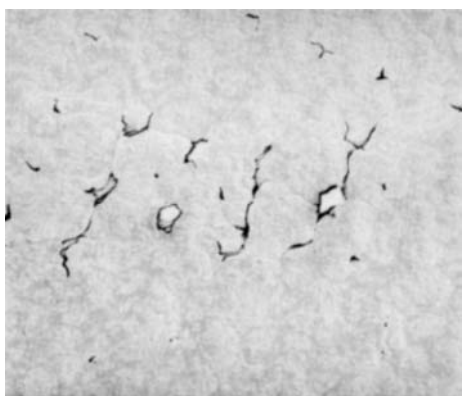
5 |——| 1 mm

Examination of the face of the coated fabric reveals a pattern of small cracks in the thick Hypalon layer as the first indication of breakdown, with the nylon fabric (highlighted by charging in the electron beam) beginning to show through, **40A(5)**. On the reverse side, with a thin Hypalon layer, the damage was much more severe, **40A(6)**.

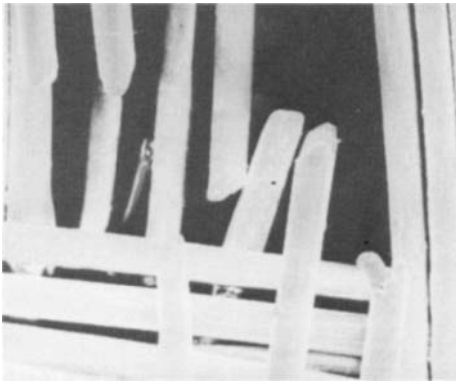
1

Along worn lines, where the exposed underlying fabric had not broken completely, some filament breaks can be seen, **40B(1)**, together with long splits penetrating down into the filaments, **40B(2)**. Surface peeling of filaments can also be seen, **40B(3)**.

(1) From region where fabric is exposed, but yarns are not broken, except for a few filaments. (2),(3) Development of filament damage. (4a, b) Regions of more severe wear. (5) Filaments some distance back from a yarn break. (6) Filaments at a yarn break.

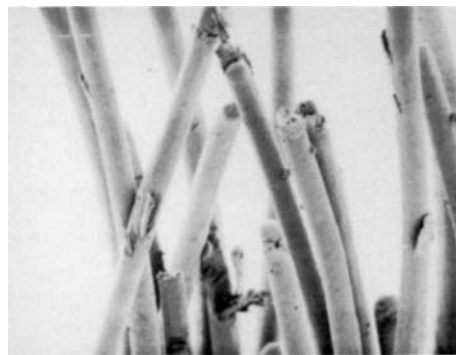
5

Complete breakage of yarns is shown in **40B(4a)**, and often runs straight across a line of yarns, **40B(4b)**. Damage to the filaments can be detected some way back from the broken end, **40B(5)**, and is characterized by splitting. A long central split at the end of a broken filament can be seen in **40B(6)**, although the ends become rounded by further wear. This form of filament failure probably results from repeated bending, as shown in laboratory flex fatigue (Chapter 12).

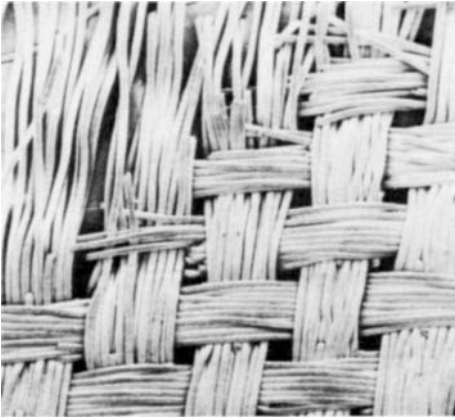
1

The effect of natural weathering can be seen in a polyester fabric, which had been used in the form of two burgees flying at the mast-head of sailing dinghies for two or three seasons. The first burgee had almost disintegrated, and was torn at the edges, **40C(1)**. The filament break, **40C(2)**, is typical of light-degraded material. Away from the breaks the fibre surfaces have a rough and pitted appearance, **40C(3)**, and loss of material, **40C(4)**. At high magnification it can be seen that, in addition to the holes, there are many fine cracks or crazes

(1) Torn region at edge of fabric. (2) Broken end of filament. (3) Surface of yarn crowns, with one broken filament. (4) Part of fibre away from broken end, with thinning due to loss of material. (5) Crazing of filament surface. (6) Second burgee, not as severely damaged.

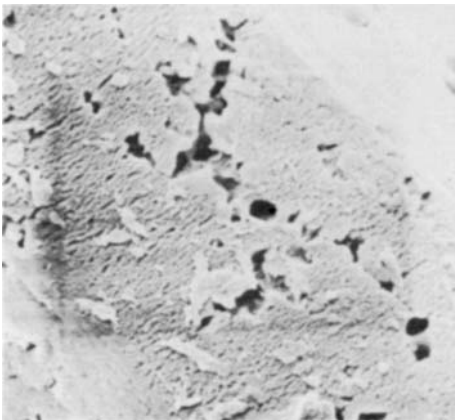
5

perpendicular to the fibre axis, **40C(5)**. The other burgee was not quite as badly damaged, and it shows holes, but no fine crazes, on the fibre surfaces, **40C(6)**. The general impression is of weakening of the fibre due to the influence of light and perhaps some chemical action, with a few broken filaments on the yarn crowns, but most of the filament breakage concentrated in the tears along both warp and weft directions.

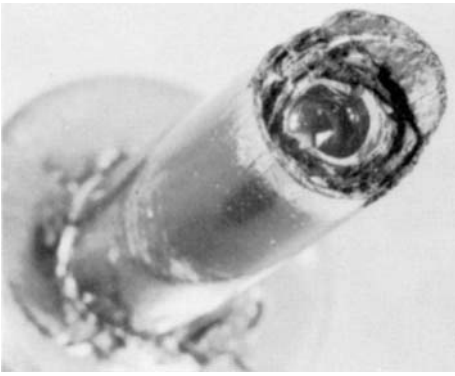
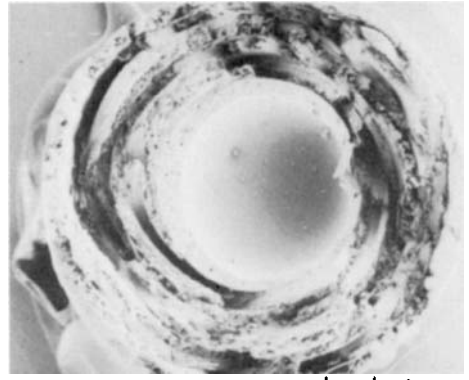
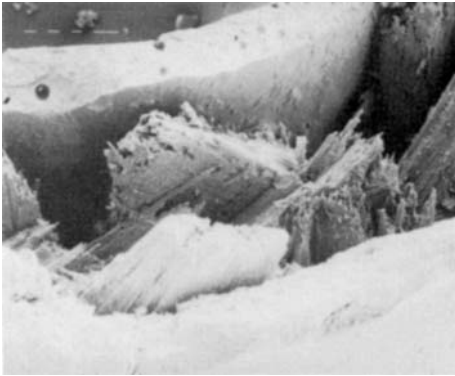
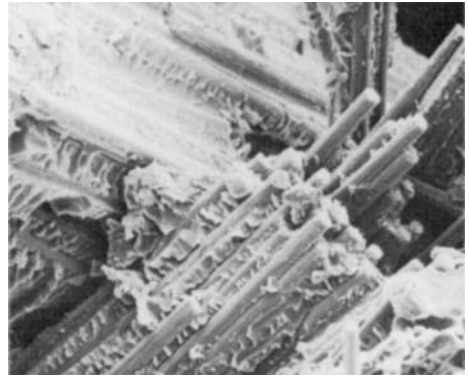
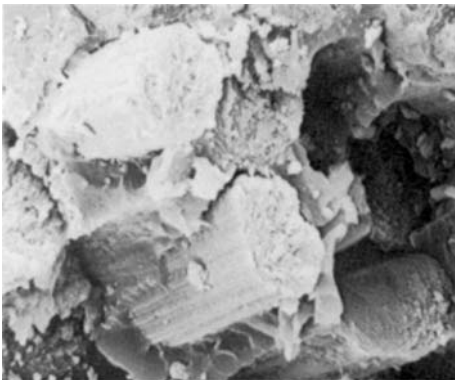
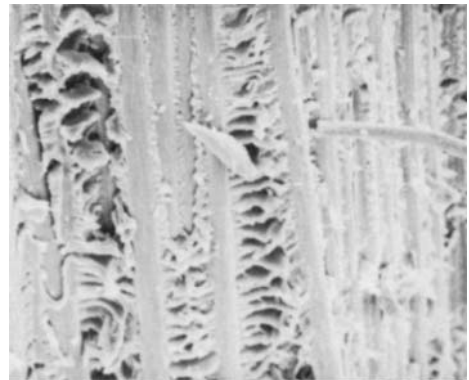
The next four examples are from sporting uses. The breakage of the shaft of a carbon fibre/epoxy badminton racket illustrates in real use the type of failure found in composite testing, as illustrated in Chapter 26. The shaft had broken near the point at which it joined the head of the racket. A general view of the fractured end is shown in the photograph, **40D(1)**. The shaft, which is made by winding angled plies of carbon fibre, is hollow; but some glue filling the central hole can be seen in the SEM view, **40D(2)**. The breakage of the several layers of carbon yarns is clearly apparent in **40D(2),(3)**. The effects observed and shown in **40D(4)** include fibre breakage, fibre pull-out and delamination. The detail of individual fibre breaks can be seen in **40D(5)**, and of delamination in **40D(6)**.

Plate 40D — Breakage of the shaft of a badminton racket made from a carbon fibre composite.
 (1) Photograph of fracture. (2) End-on view of fracture. (3)–(6) Detail of breakage.

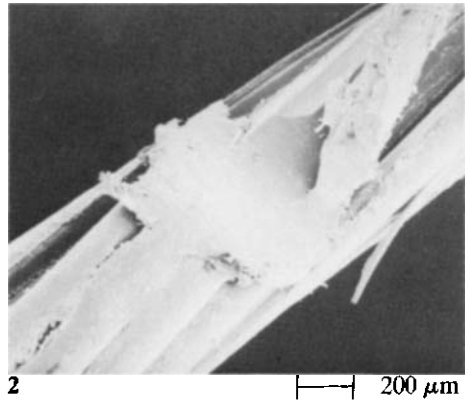
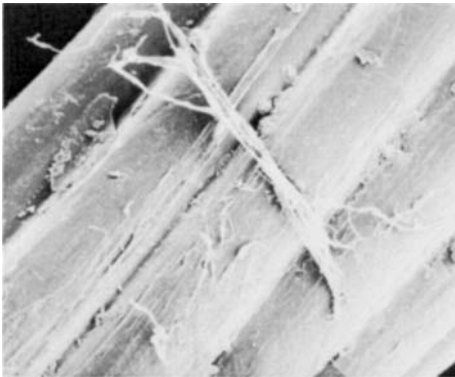
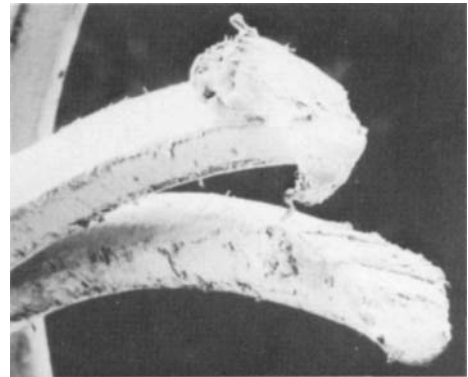
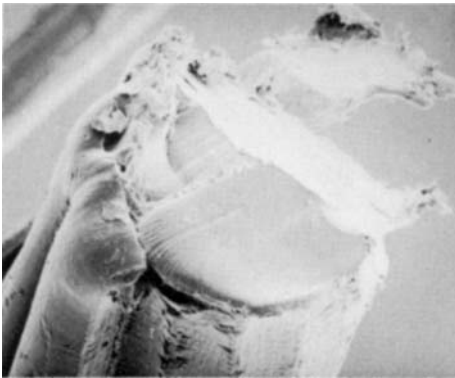
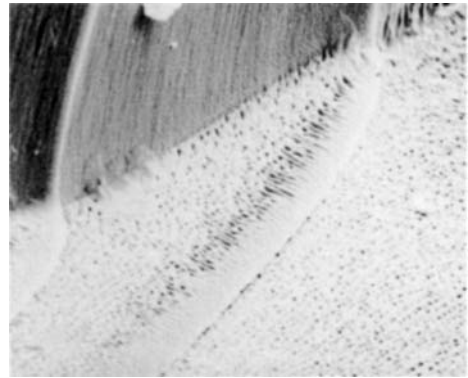
The second example is a string from a badminton racket, **40E(1)**, which has broken where strings cross, **40E(2)**. At the centre of the racket there is general wear, shown by peeling away of fibrils from the surface of the string, **40E(3)**. The actual break, which is a single sudden event, shows a complicated morphology, **40E(4)–(6)**.

Plate 40E — Broken string of badminton racket.

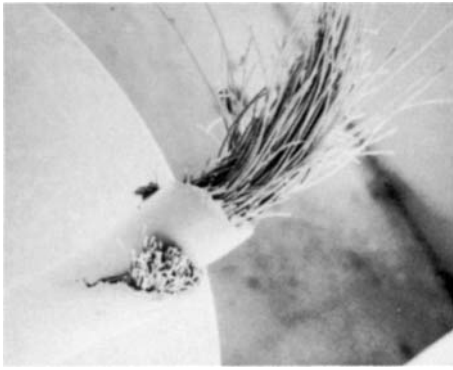
1 | 1 mm

Plate 40F — Break of tennis racket string.

(1) General view of break. (2) Detail of damage to sheath. (3),(4) Fibre breaks.

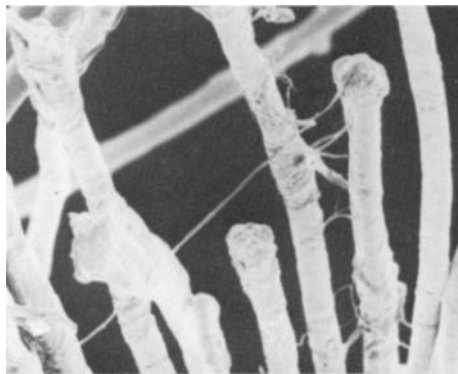
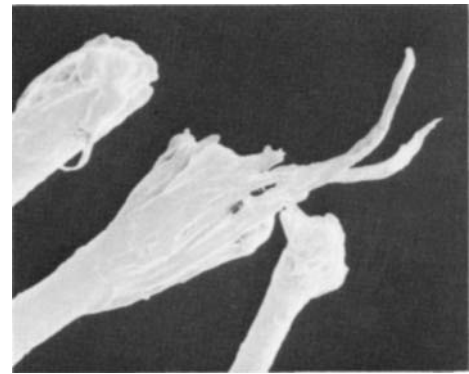
Break of one strand of archery bowstring.

(5) Fibres near break. (6) Detail of breakage.

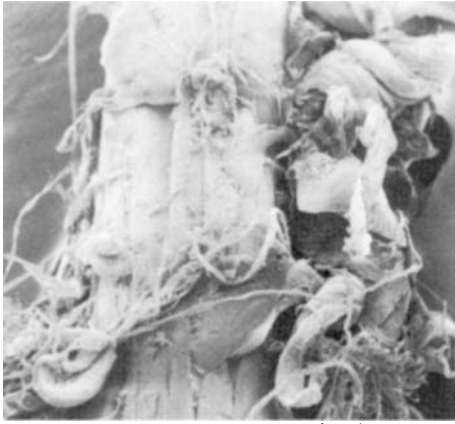
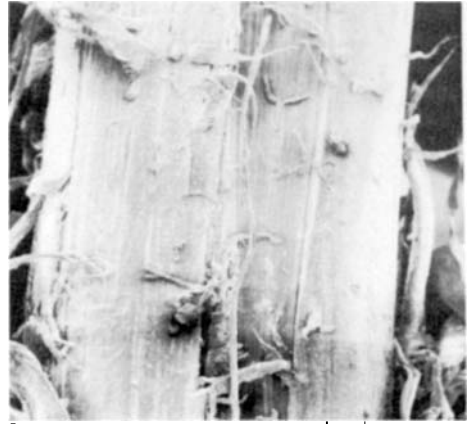
Plate 40G — Four forms of fibre damage.

(1),(2) Nylon 6 monofil used to transport sheets through an automatic laundry, after 10 hours service. (3) Nylon filament removed from worn tyre; optical micrograph, from S. C. Simmens. (4) Break in nylon filament from a parachute cord, deployed during aircraft landing. (5),(6) Hole in polypropylene fabric, which had been used to filter china clay.

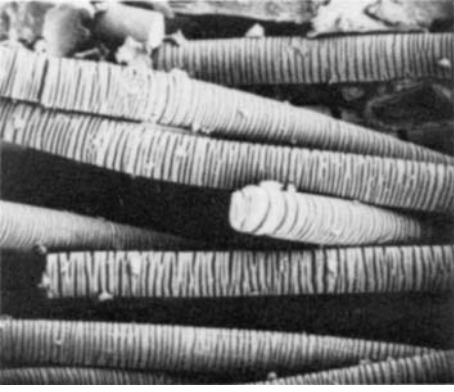
1

Plate 40H — Polypropylene fabric after five years exposure to light in a cover on the back seat of a car.
 (1) Filaments with transverse cracks. (2) Internal appearance after splitting open.

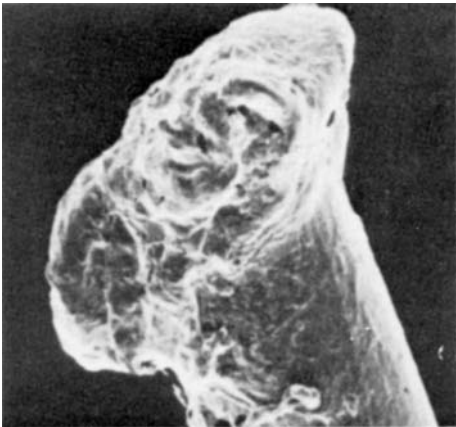
5

The effects of high-speed ballistic impact are shown in studies by C. Cork at UMIST. A bullet fired at 514 m/s at a nylon fabric penetrates the material and breaks the nylon fibres, **40H(5)**, with the typical high-speed rupture form, shown in Chapter 6. Nowadays, Kevlar has replaced nylon as the material used in 'bullet-proof vests'. Under ballistic impact it fails by axial splitting, **40H(6a,b)**, in a manner similar to a slow-speed tensile break.

The rupture of nylon and Kevlar fibres as a result of ballistic impact are shown in **40H(5),(6)**, but in view of the limited information on the form of damage by bullets, as referred to in Chapters 44 and 46, it is worth including more pictures from the laboratory studies of C. Cork at UMIST. When a bullet impacts at high speed on a woven fabric, a pyramidal out-of-plane wave propagates across the specimen, **40L(1)**, preceded by an in-plane wave, which contributes to the increase in length. In a more isotropic knit fabric, **40L(2)**, the deformation is conical. After a nylon fabric has been penetrated at the comparatively slow speed of 254 m/s, **40L(3)**, there is extensive local damage around the hole made by the bullet and the effects of the in-plane extension along the warp and weft directions can be seen reaching to the edge of the fabric specimen. At the higher speed of 514 m/s, **40L(4)**, the hole is much sharper and the warp and weft deformation lines do not extend as far, because penetration has been completed before the wave reaches the edge of the circle. Similar differences are seen in a Kevlar fabric, **40L(5),(6)**.

(5) From nylon fabric, impacted by bullet at 514 m/s. (6) From Kevlar fabric, impacted at: (a) 240 m/s; (b) 523 m/s.

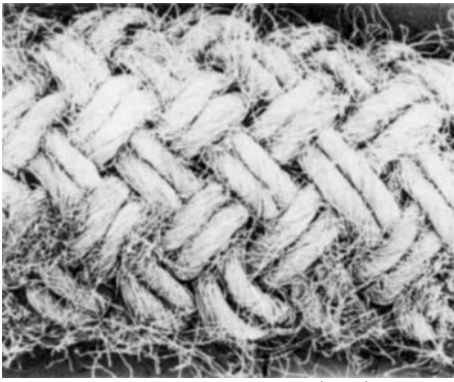
1

An example of failure caused by direct surface wear is shown in **40I**. This is a shoe-lace,

which had broken after comparatively little use, as a result of rubbing against the metal eyelets. The outer cover of the lace is a viscose rayon braid, **40I(1)**, in which the fibre surfaces had been worn flat, **40I(2)**, and then had eventually broken. The broken ends can be seen in the interstices of the braid, **40I(3a,b)**. An unusual broken rayon fibre, from close to the place where the braid had broken, is shown in **40I(4)**. The exposed cotton yarns of the core, **40I(5)**, had then broken by multiple splitting, **40I(6)**. A higher-quality lace would be of stronger fibres, such as nylon.

Plate 40I — Broken shoe-lace.

- (1) Surface of outer braid, near the break. (2) Surface wear and break of rayon fibres in braid. (3a, b) Broken fibres in braid. (4) Rayon break, close to break in lace. (5) Exposed cotton yarns from core. (6) Detail of cotton fibre damage.

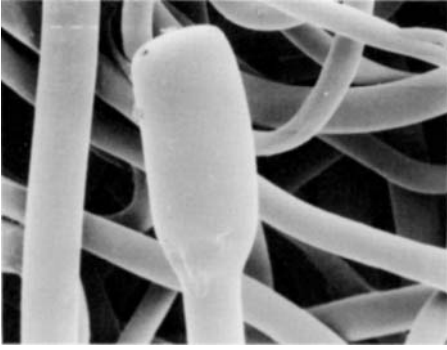
1

Papermakers' felts are subject to severe forces in hot wet conditions as they are driven through the machines and compressed between rollers. M. A. Wilding and C. Cork at UMIST have examined the damage which can be seen in used felts. Only limited details of the construction and use of the felts, which are made of nylon fibres, were available. **40J(1)** shows the surface of an unused felt, including a bulbous end, probably resulting from some heat treatment. Bulbous ends are most common on the paper side. Cut ends are also found. After use, **40J(2)**, there is considerable surface wear of the fibres, flattening and multiple split breaks. These effects are also seen in part-used felts. The felt in **40J(3)** contains a mixture of coarse (44 dtex) and finer (17 dtex) fibres and shows severe wear after 2 days use, with considerable splitting and peeling of fibres. The damage appears to be less severe after 14 and 16 days respectively in **40J(4),(5)**, which are made of finer fibres (3.3 and 6.7 dtex, respectively), though there is considerable flattening and some splitting. **40J(6)** shows clear examples of multiple splitting failures.

Plate 40J — Wear in papermakers' felts.
(1) Unused felt. (2) Used felt. (3)-(6) Part used felts.
